## A Human Factors Analysis of the Asiana Flight 214 Accident

*William Bramble, Ph.D.  
Senior Human  
Performance Investigator*

# Accident Information

- July 6, 2013
- Boeing 777-200ER
- Scheduled flight
- Seoul → San Francisco
- Training flight
- Visual meteorological conditions
- Light winds

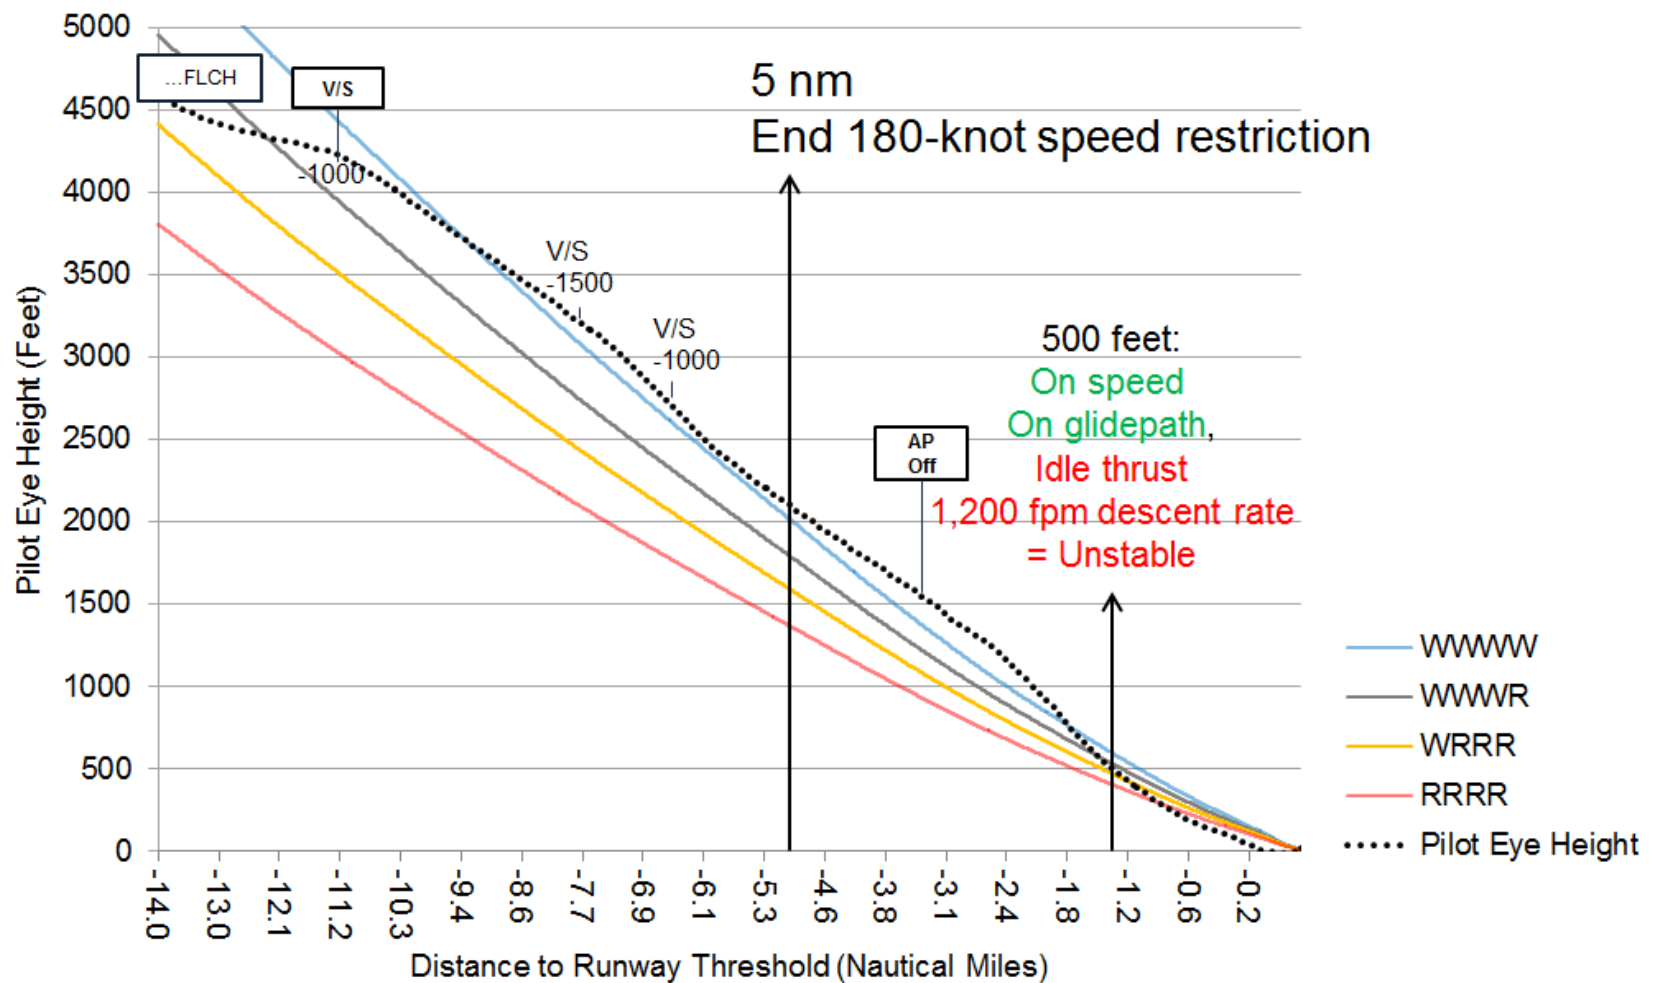
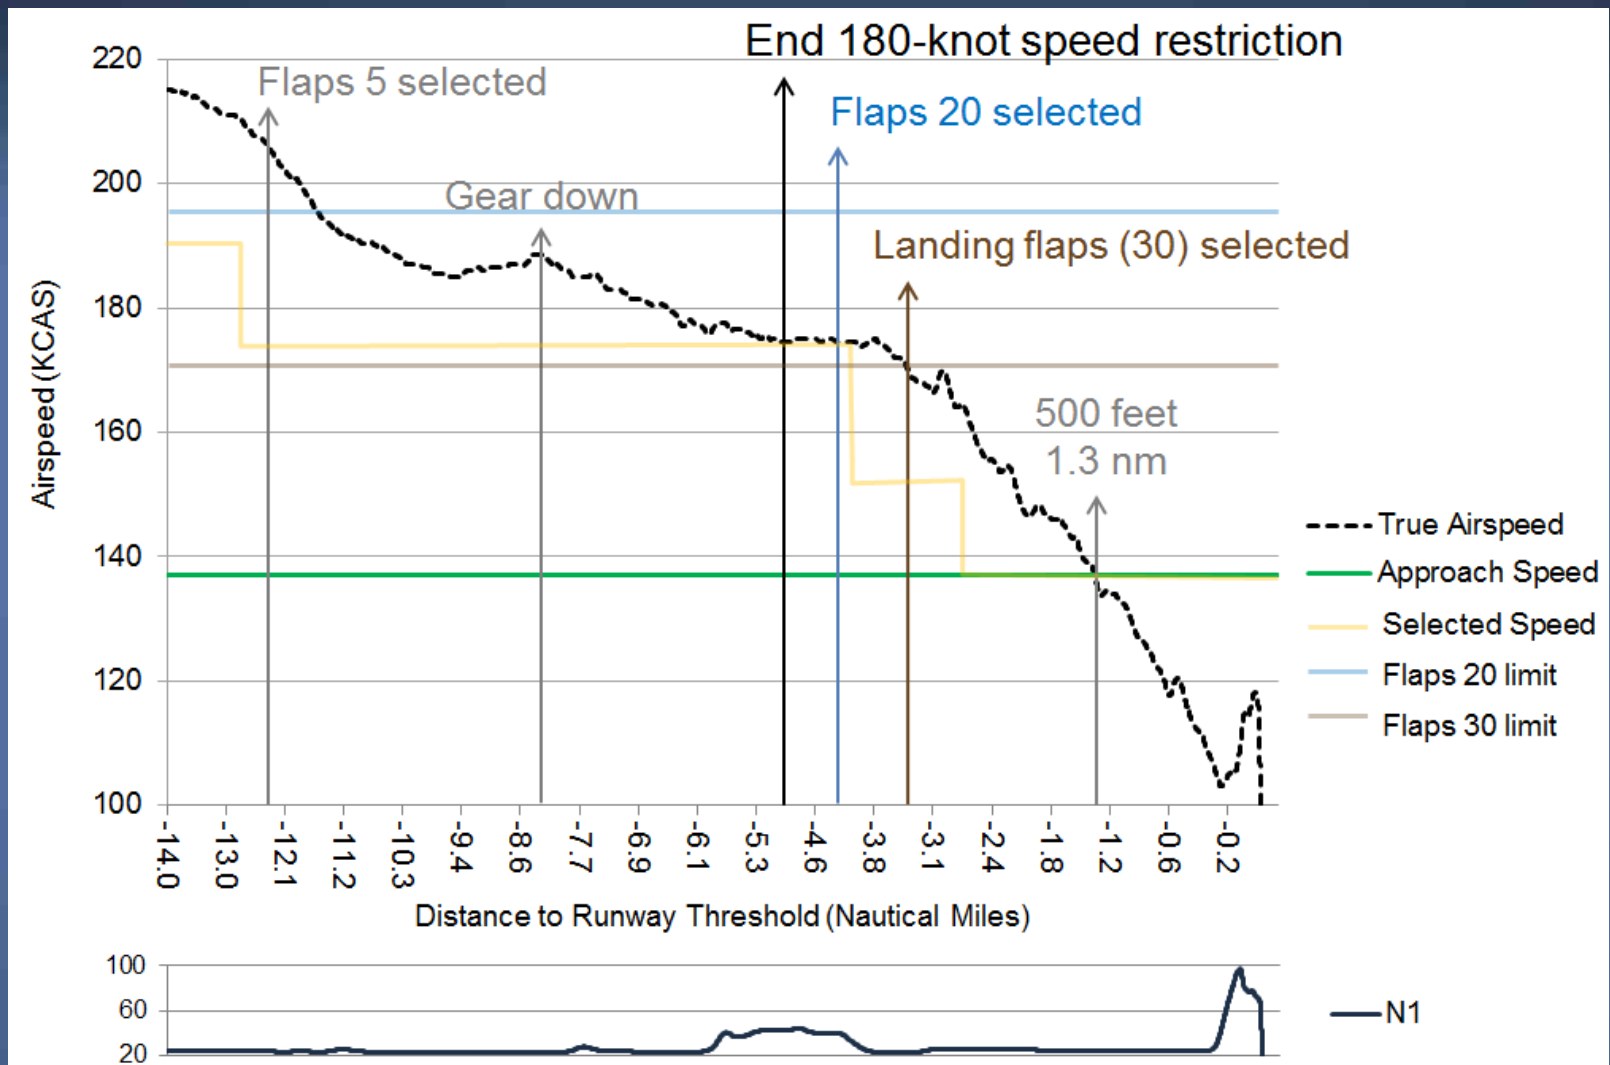
# Mismanagement of the Descent

PF's  
inadequate  
training on  
planning,  
executing  
visual  
approaches

Flightcrew's  
mismanagement  
of airplane's  
descent

- Pilots “often lack sufficient in-depth knowledge and skills to most efficiently and effectively accomplish flightpath management related tasks” \*
- The PF had practiced speed-restricted, high energy, straight-in visual approaches without a glideslope
- Flight path management skills can atrophy from lack of practice

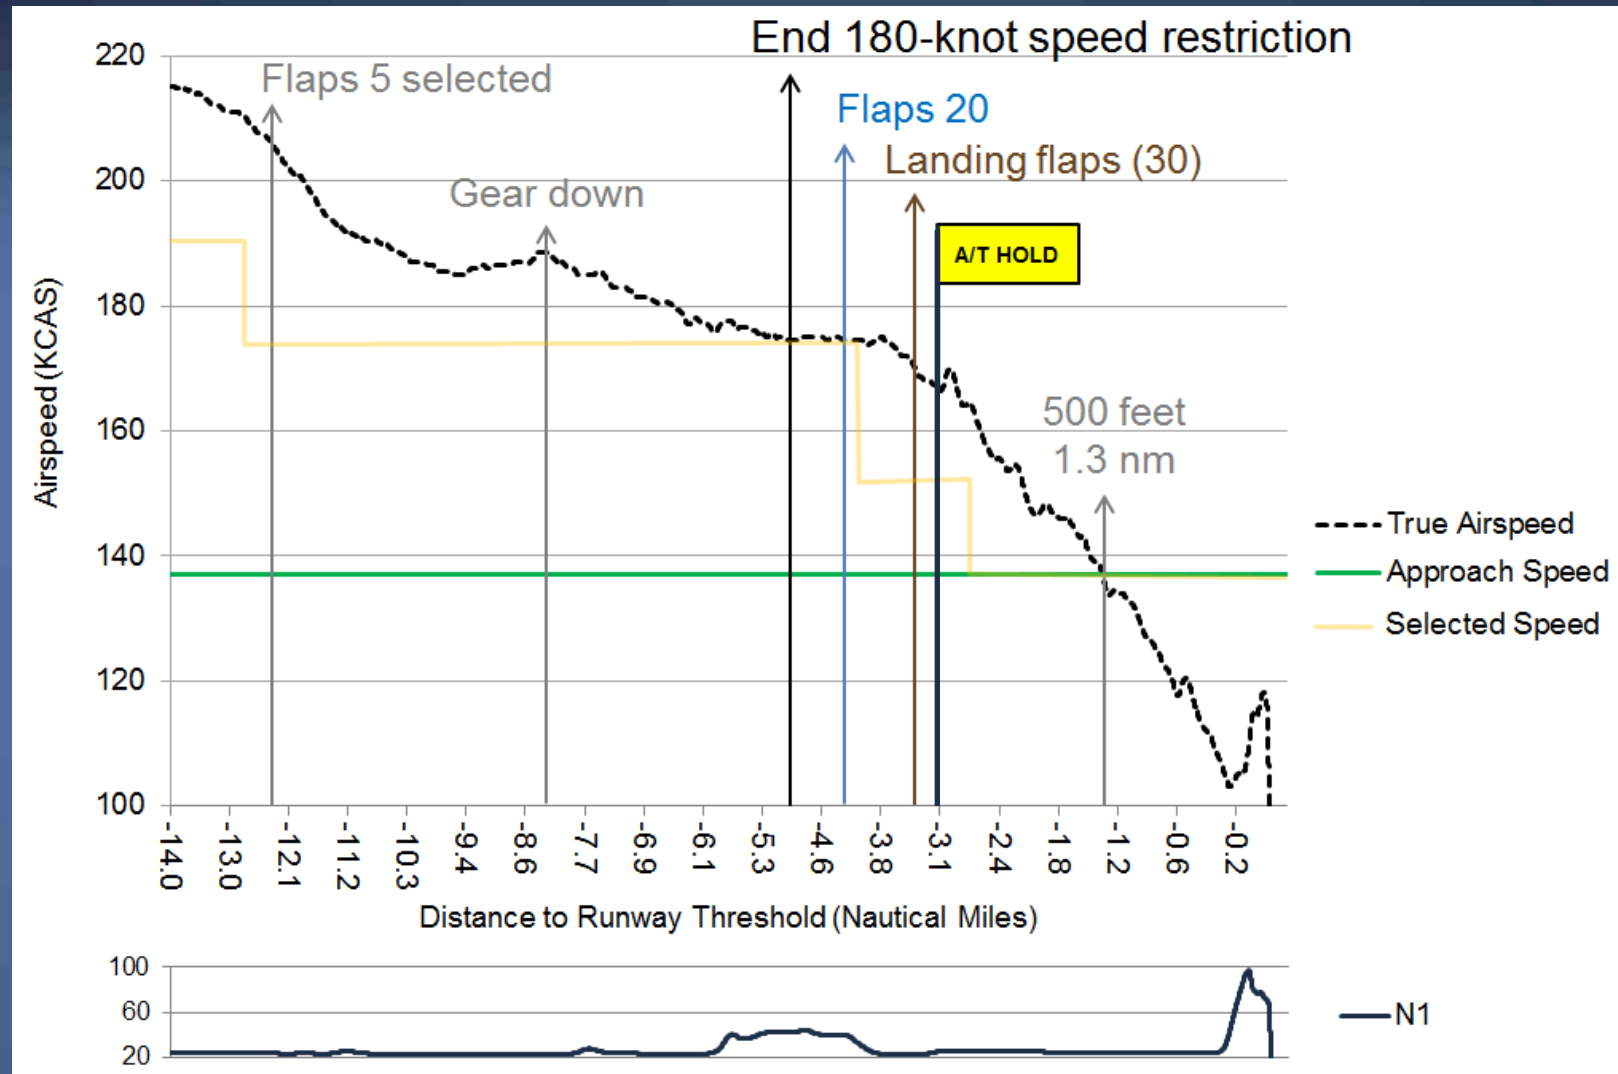
# Deactivation of Automatic Airspeed Control

A/P Status	A/P Pitch	A/T Thrust	Speed Control
1	A/P	V/S	SPD	With thrust (A/T)
2	A/P	FLCH SPD	THR	With elevator (A/P)
3	FLT DIR	FLCH SPD	THR	With elevator (Pilot)
4	FLT DIR	FLCH SPD	HOLD	With elevator (Pilot)
5		FLCH SPD	HOLD	Not specified

Complexities of the autoflight system

Inadequate documentation

Inadequate training

PF had inaccurate understanding of AFCS

Increased likelihood of mode error

PF's unintended deactivation of automatic airspeed control

- Pilots often have difficulty comprehending subtle interconnections between aircraft sub-systems and AFCS mode logic
- Much learning occurs on the line
- Gaps in pilot mental models are problematic in dynamic, nonroutine situations, and can lead to “automation surprise”
- FAA and EASA had described certain aspects of the 777 AFDS/AT system as unintuitive
- 777 AFCS documentation and training was not sufficiently clear and comprehensive

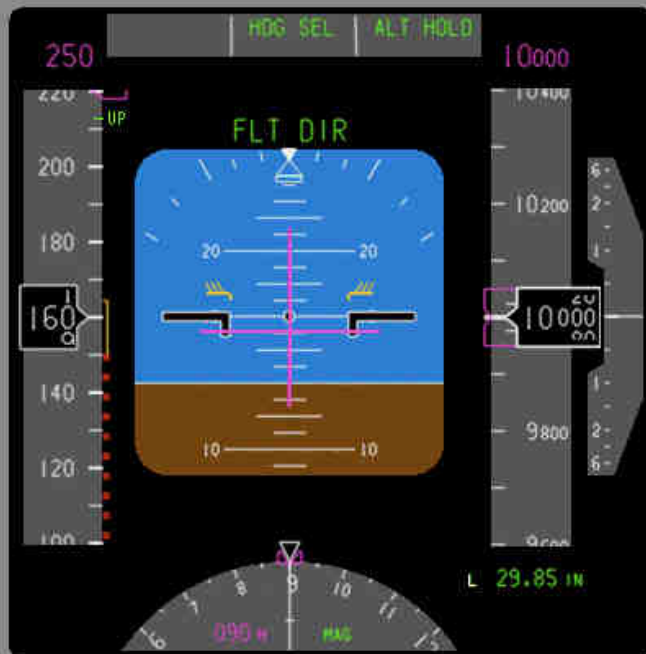
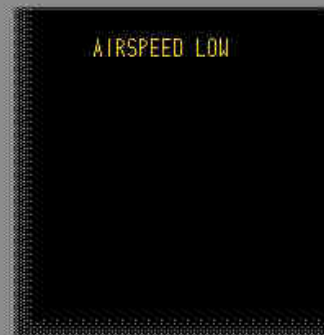
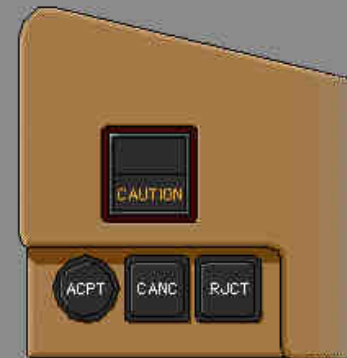
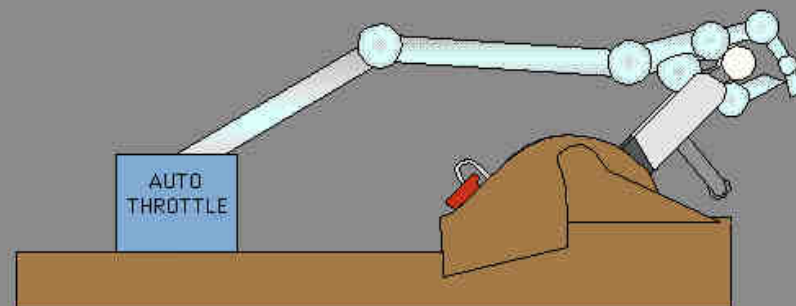
## Stall Protection Feature

- Reduces the possibility of reaching stick shaker
- No trim below minimum maneuvering speed
- Slow speed requires continuous back pressure
- Autothrottles engage automatically

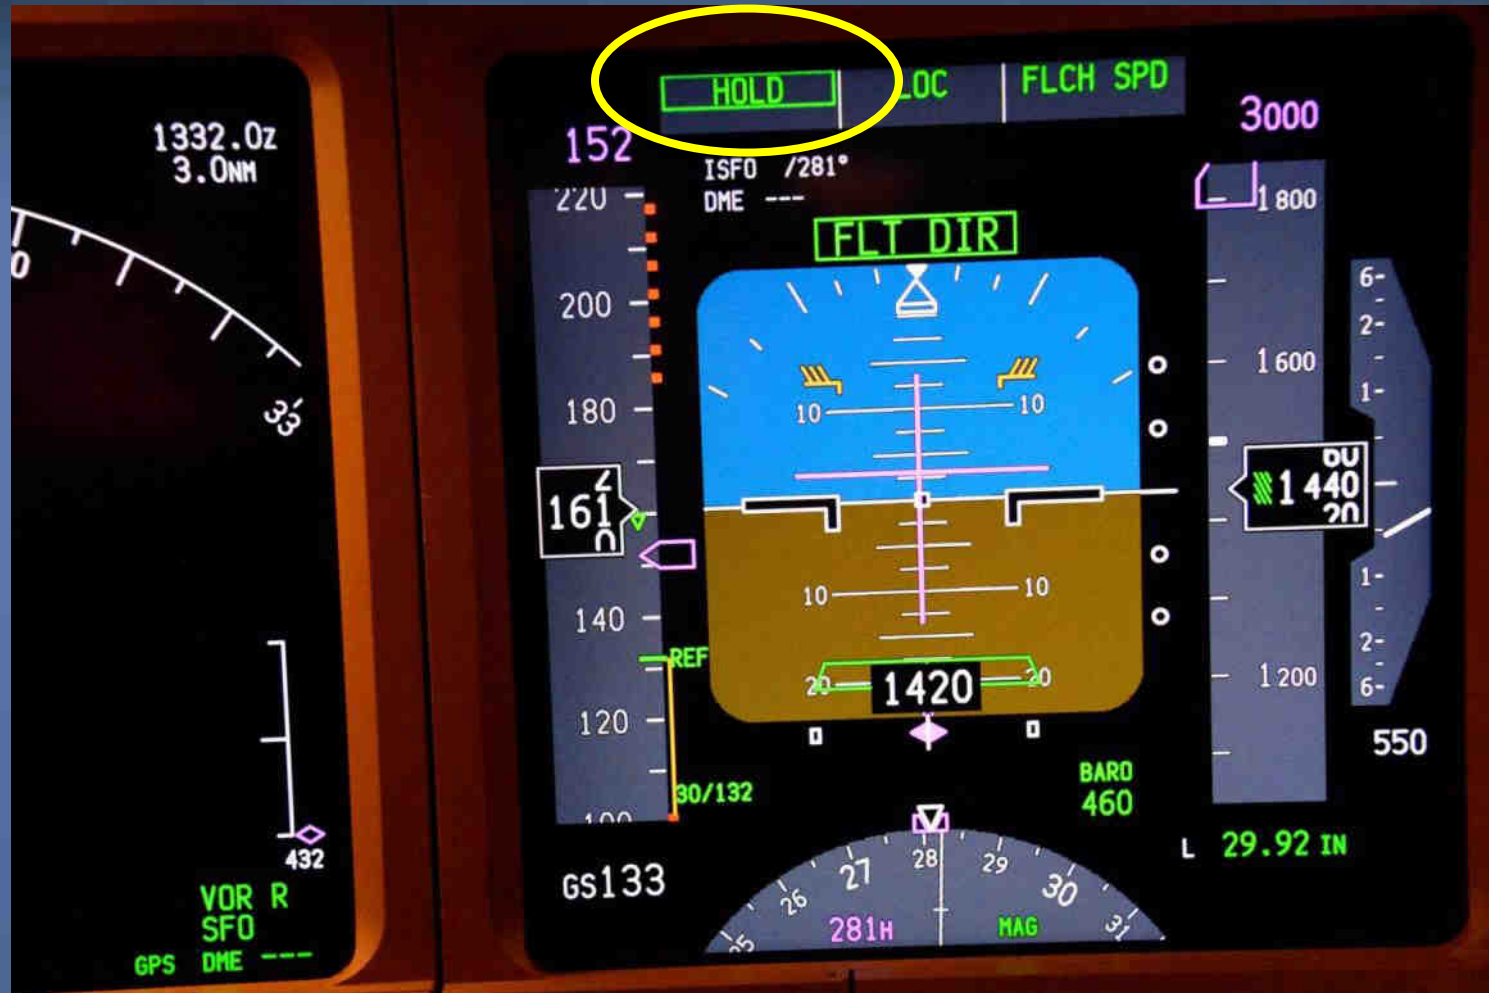
# Flightcrew Non-Detection of the PF's Error

Role confusion

Nonstandard flightcrew communication and coordination regarding use of the AFCS

Increased workload

Reduced awareness of PF's actions and degraded mode awareness

Flightcrew's non-detection of the PF's error

- The instructional nature of the flight led to blurring of PF and PM roles
- This lessened adherence to SOPs involving mode selections and callouts
- The PM was occupied with a configuration task when the PF's mode selection occurred
- The flightcrew did not detect the FLCH selection or subsequent, related mode changes
- Pilots often overlook unexpected mode changes
- The absence of a callout contributed to the flightcrew's degraded mode awareness

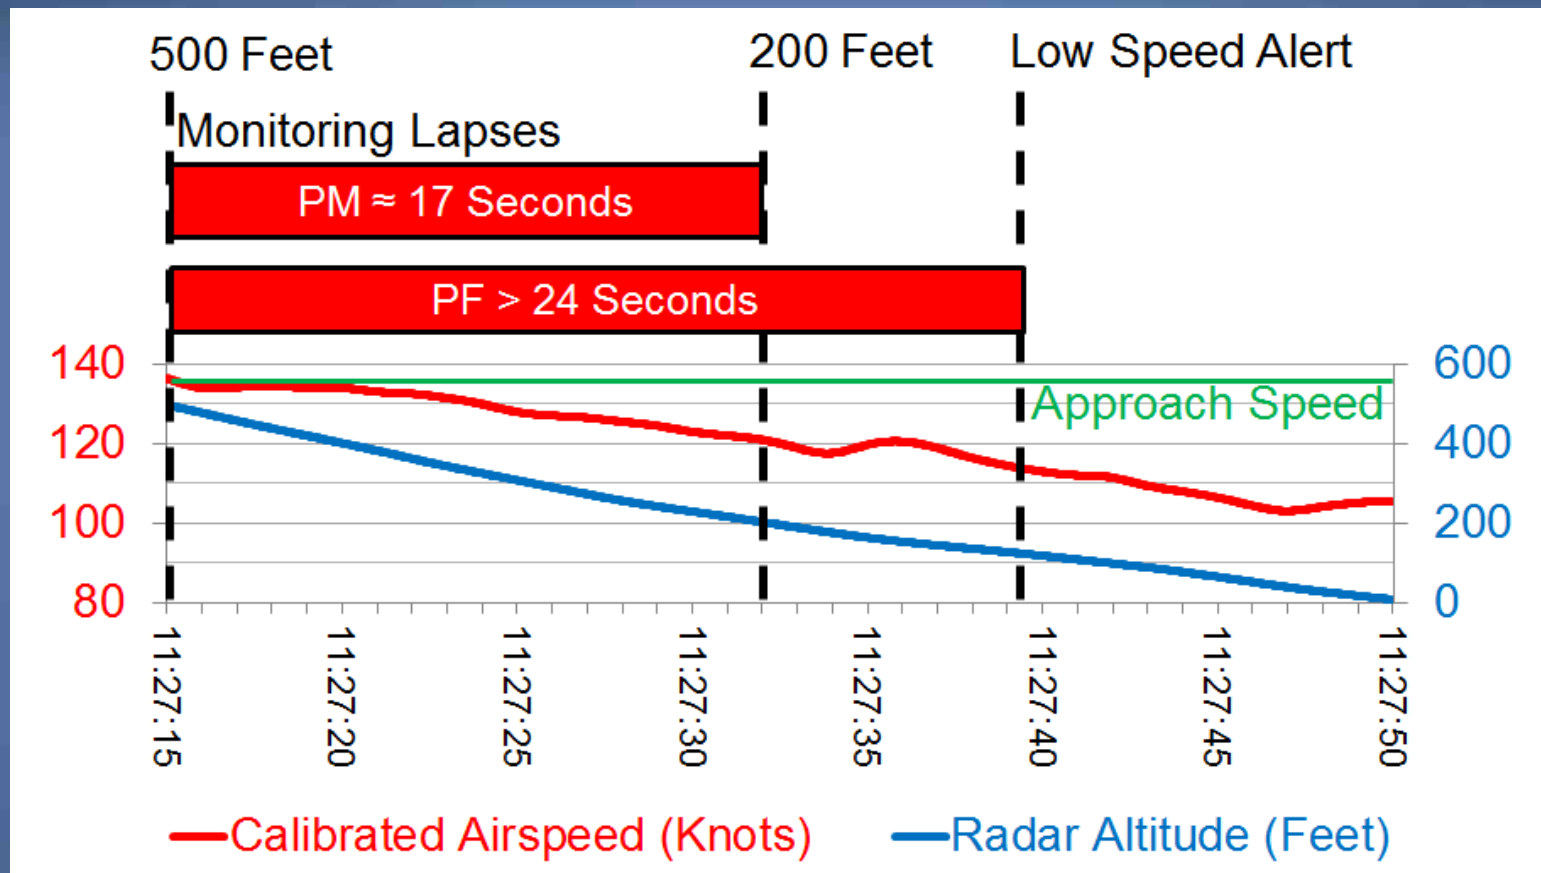
# Inadequate Monitoring of Airspeed

Expectancy

Increased  
workload

Automation  
reliance

Fatigue

Neglect of  
pitch trim

Flightcrew's  
inadequate  
monitoring of  
airspeed

- The crew expected the A/T would maintain selected speed
- The thrust levers behaved as expected (at idle) for 50 seconds after the A/T transitioned to HOLD
- Airspeed reached  $V_{\text{approach}}$  at 500 feet
- Workload was high on short final
- Monitoring of automated sub-systems decreases as workload increases (automation reliance)
- The PF did not use pitch trim
- The crew was fatigued, degrading vigilance
- First officer's view of primary displays partially obscured

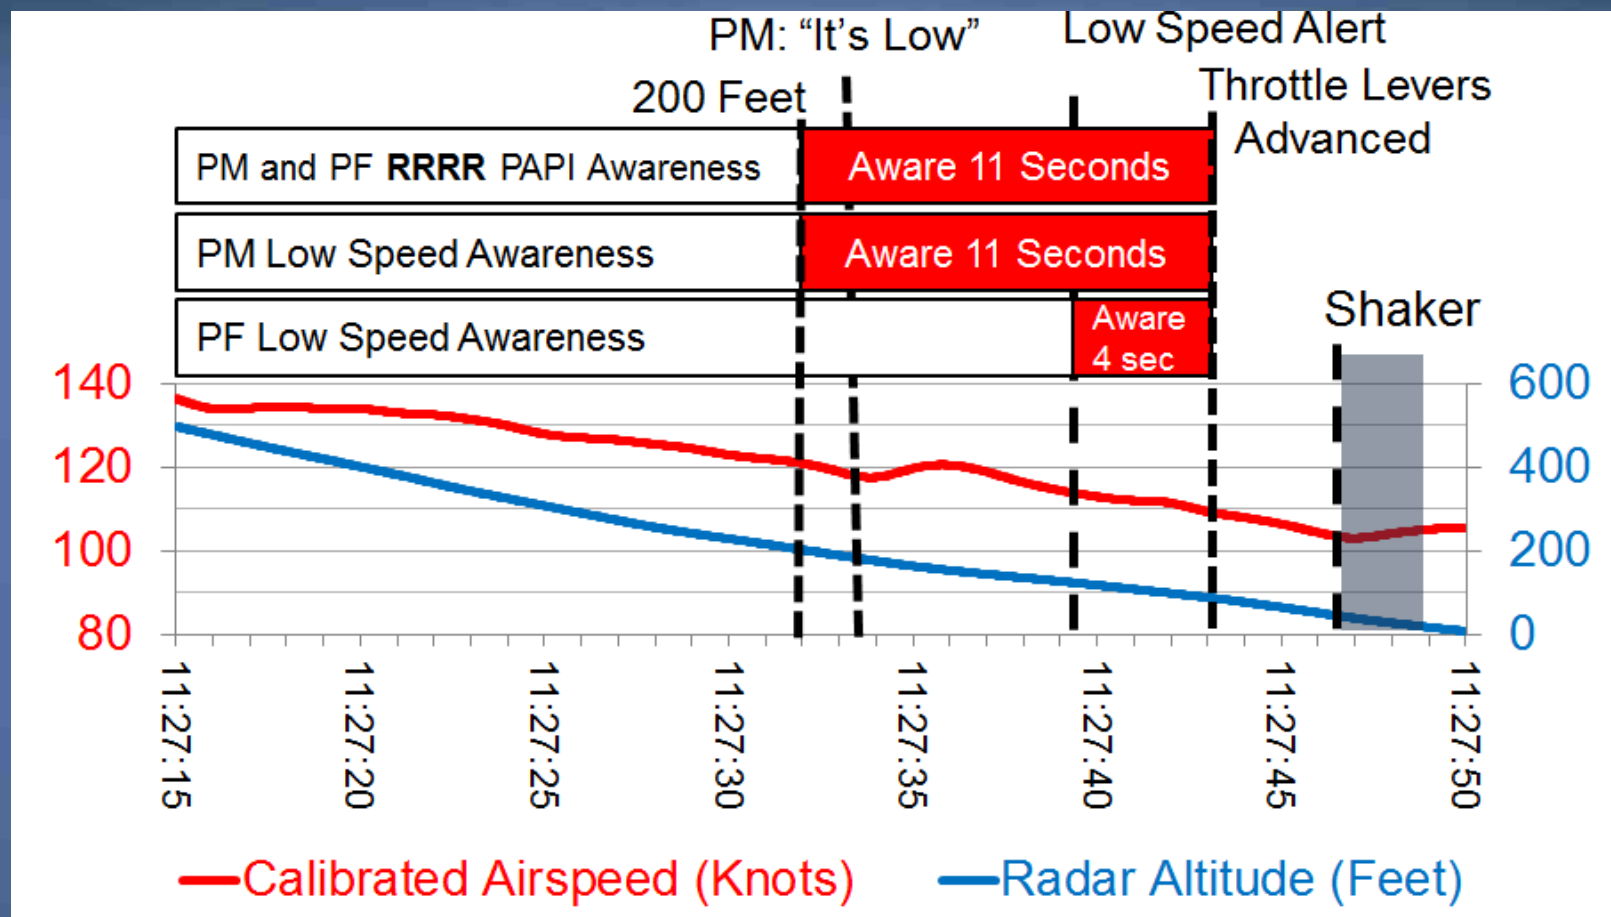
# Delayed Go-Around

Surprise

Non-standard  
communication

Role confusion

Flightcrew's  
delayed initiation  
of a go-around

- Flightcrew response times are longer for unexpected events
- PM: “It’s low” was nonspecific and possibly contributed to a delay in addressing the low airspeed
- The PF and PM each thought the other was responsible for initiating a go around
