Jetman Accident

Case Study

9th November 2023

AIFN0012/2020

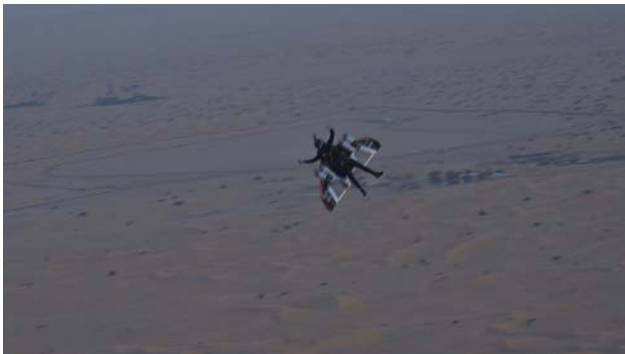
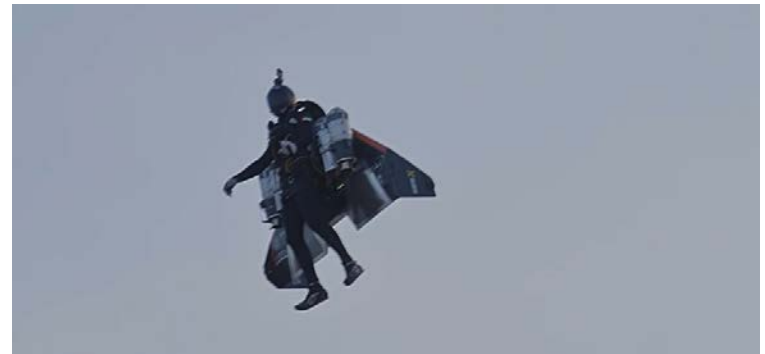
- The helicopter arrived at 4000 ft AML and hovered for 3 minutes while the Jetman was preparing himself to deploy.
- The Jetman was deployed successfully, performed some maneuvers for 6 minutes and headed back.
- The helicopter at this time was hovering at 800 ft AGL and the Jetman arrived to the helicopter location, hovering slightly above the altitude of the helicopter.
- The Jetman lowered his altitude to reach same altitude of the helicopter, then he back-leaned, back-flipped and then steep descended until impact with ground.

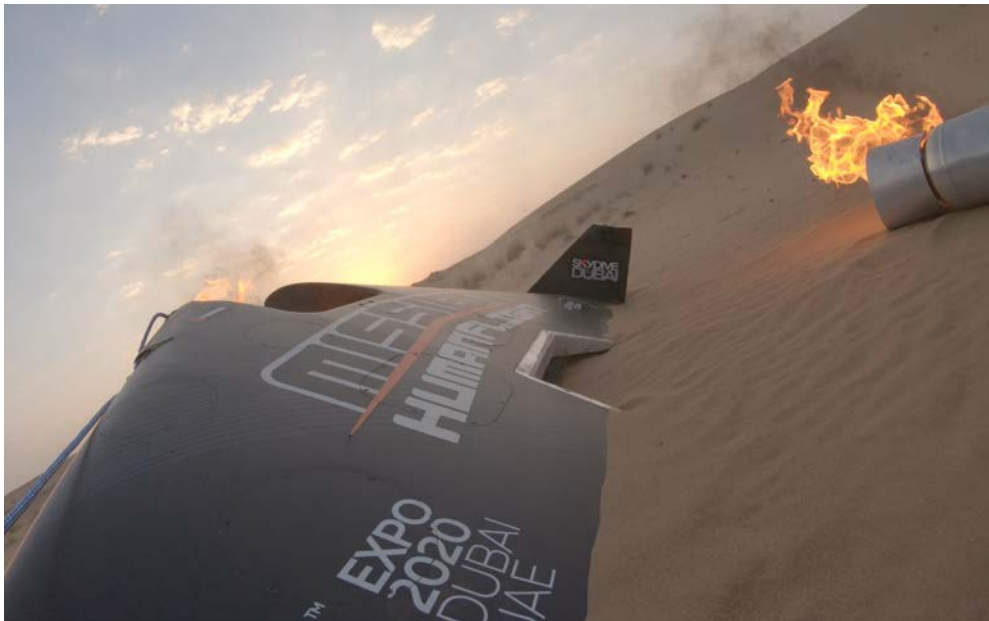
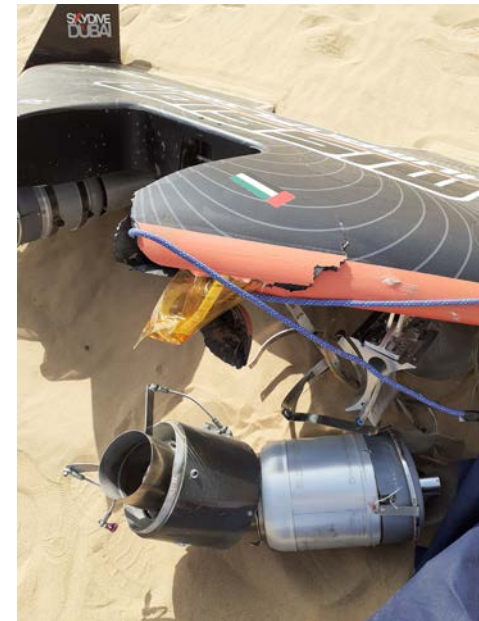
- AAIS responded to the Accident site in the desert and collected the Evidences.
- Teardown and Examinations were performed at Jetman Facility.
- Interviews were conducted, Videos from different sources were reviewed.
