National Transportation Safety Board

A Human Factors Analysis of the Asiana Flight 214 Accident

MENASASI Seminar, Dubai, United Arab Emirates, 5 November, 2015

Descent Below Visual Glidepath and Impact With Seawall Asiana Airlines Flight 214 Boeing 777-200ER, HL7742 San Francisco, California July 6, 2013

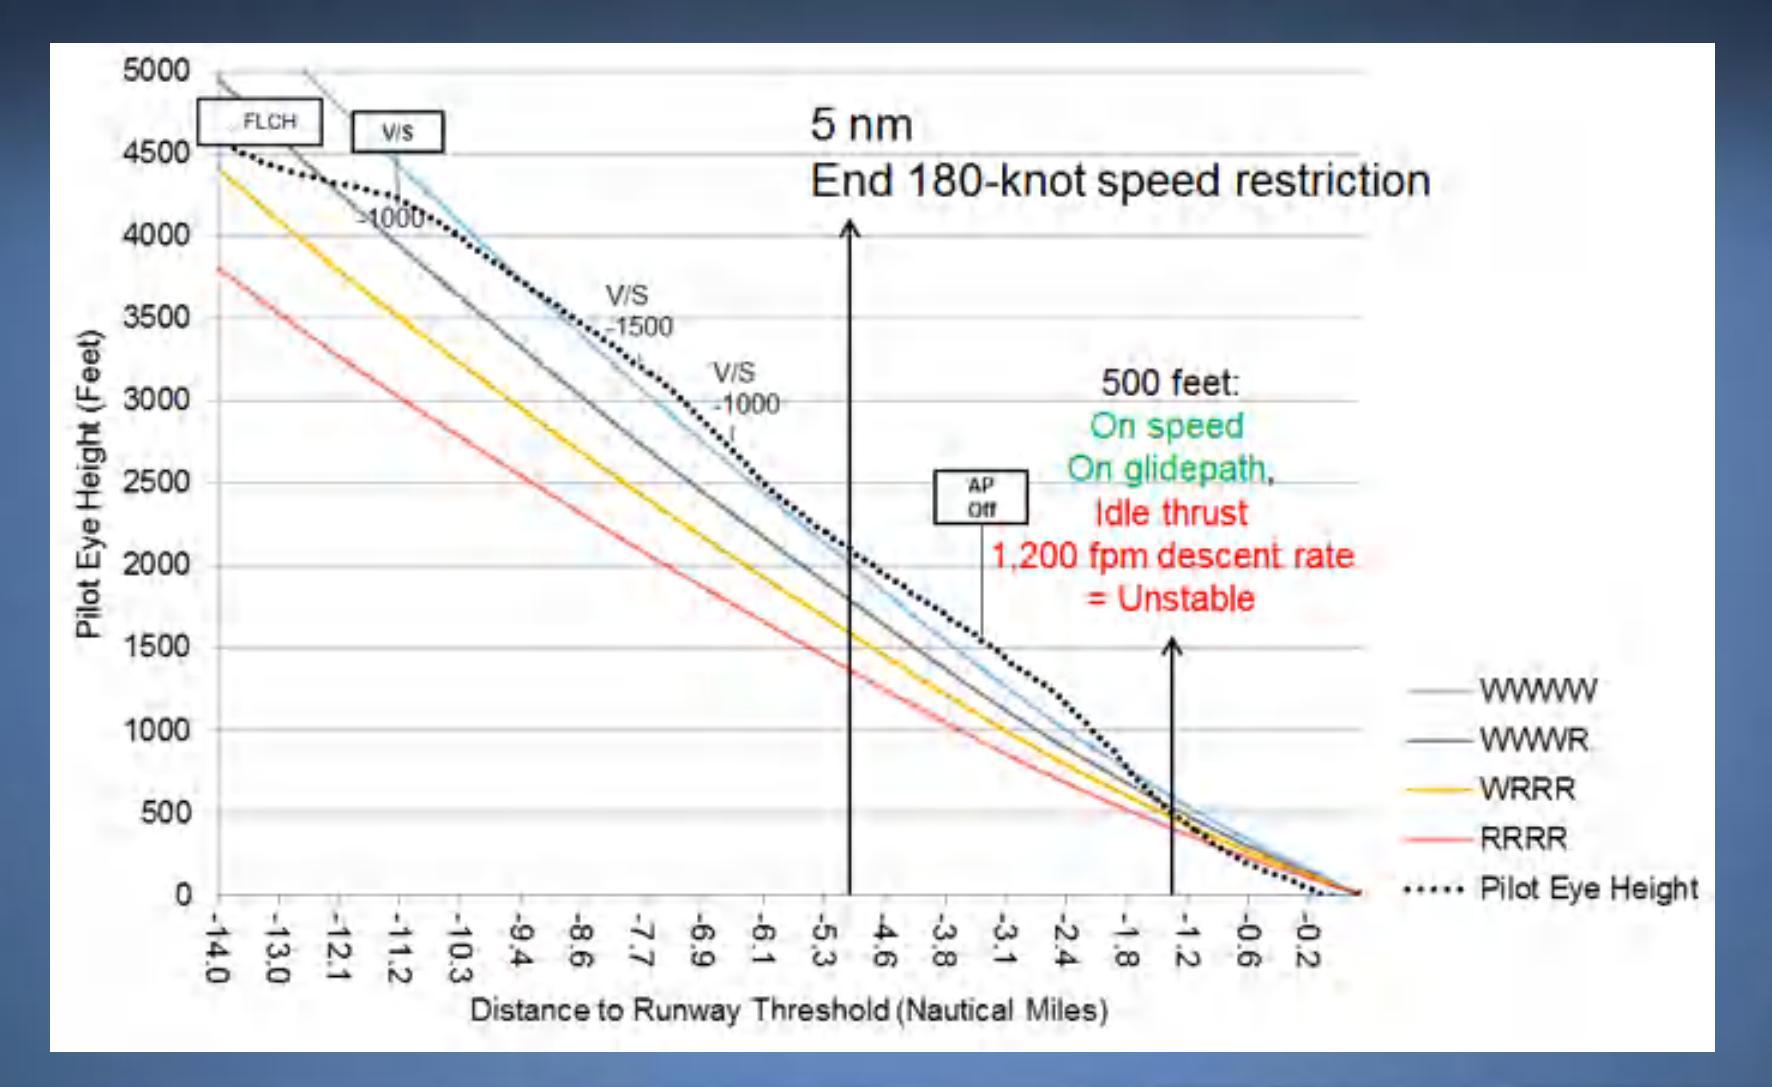
Mismanagement of the Descent

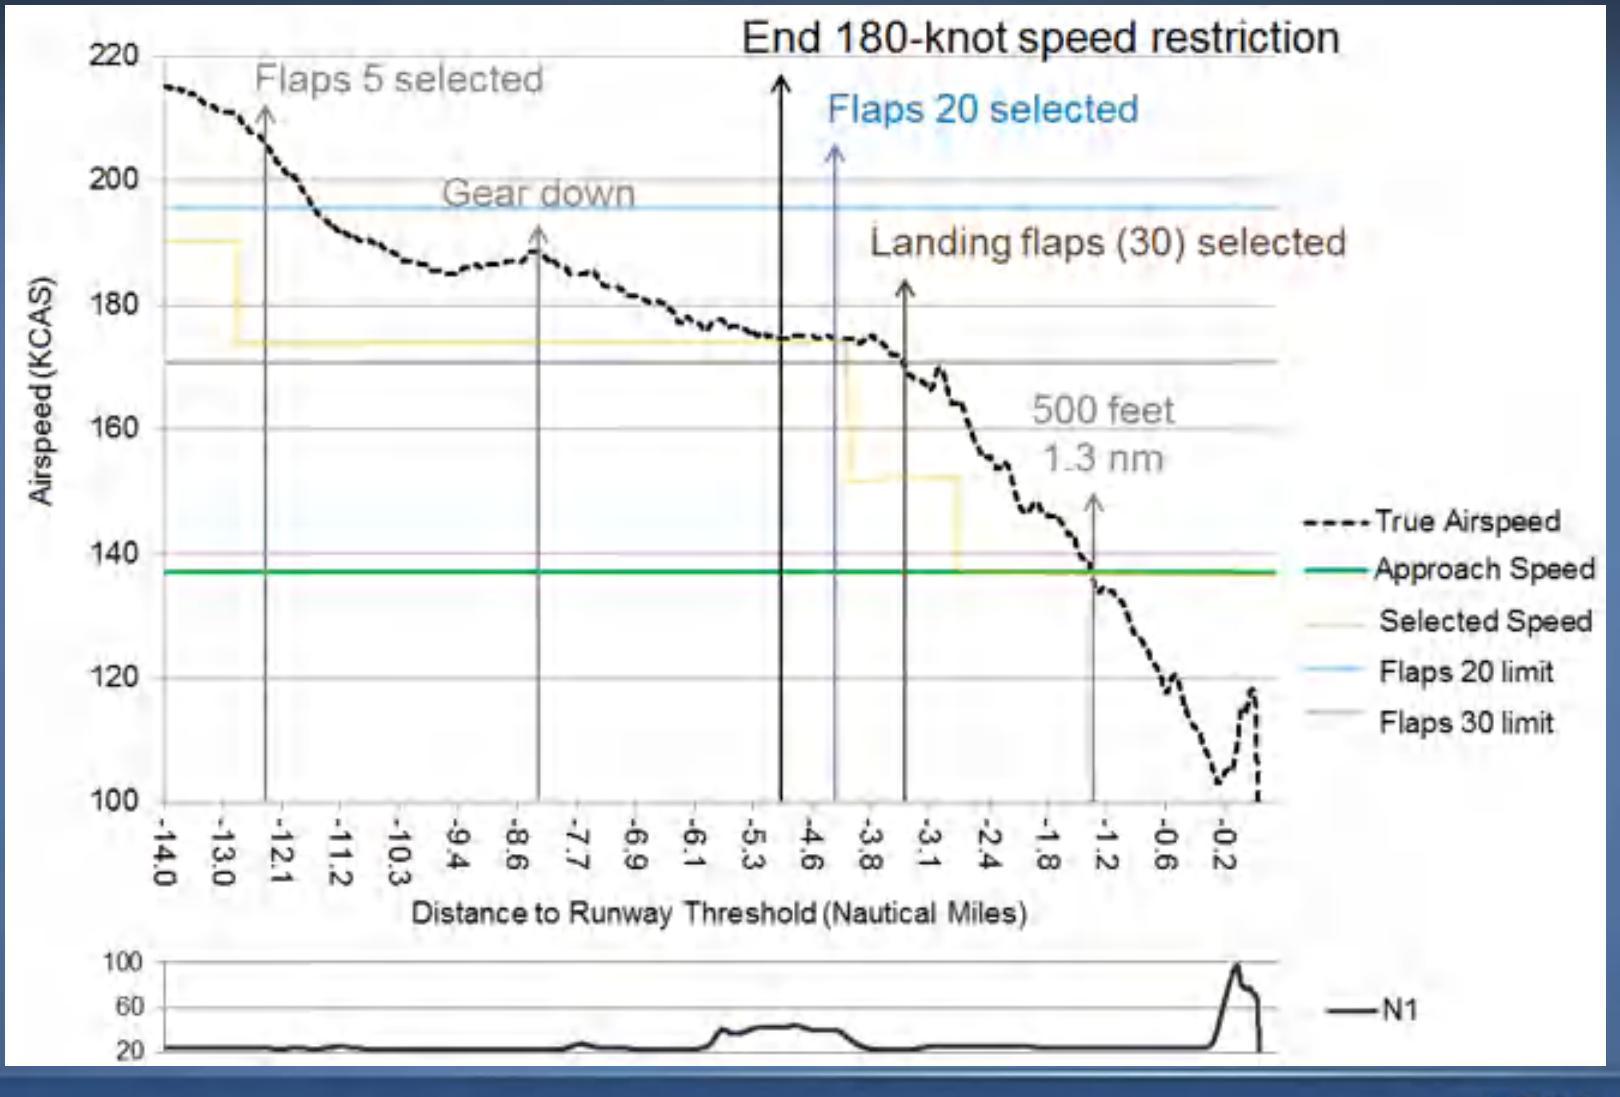
Mismanagement of the Descent

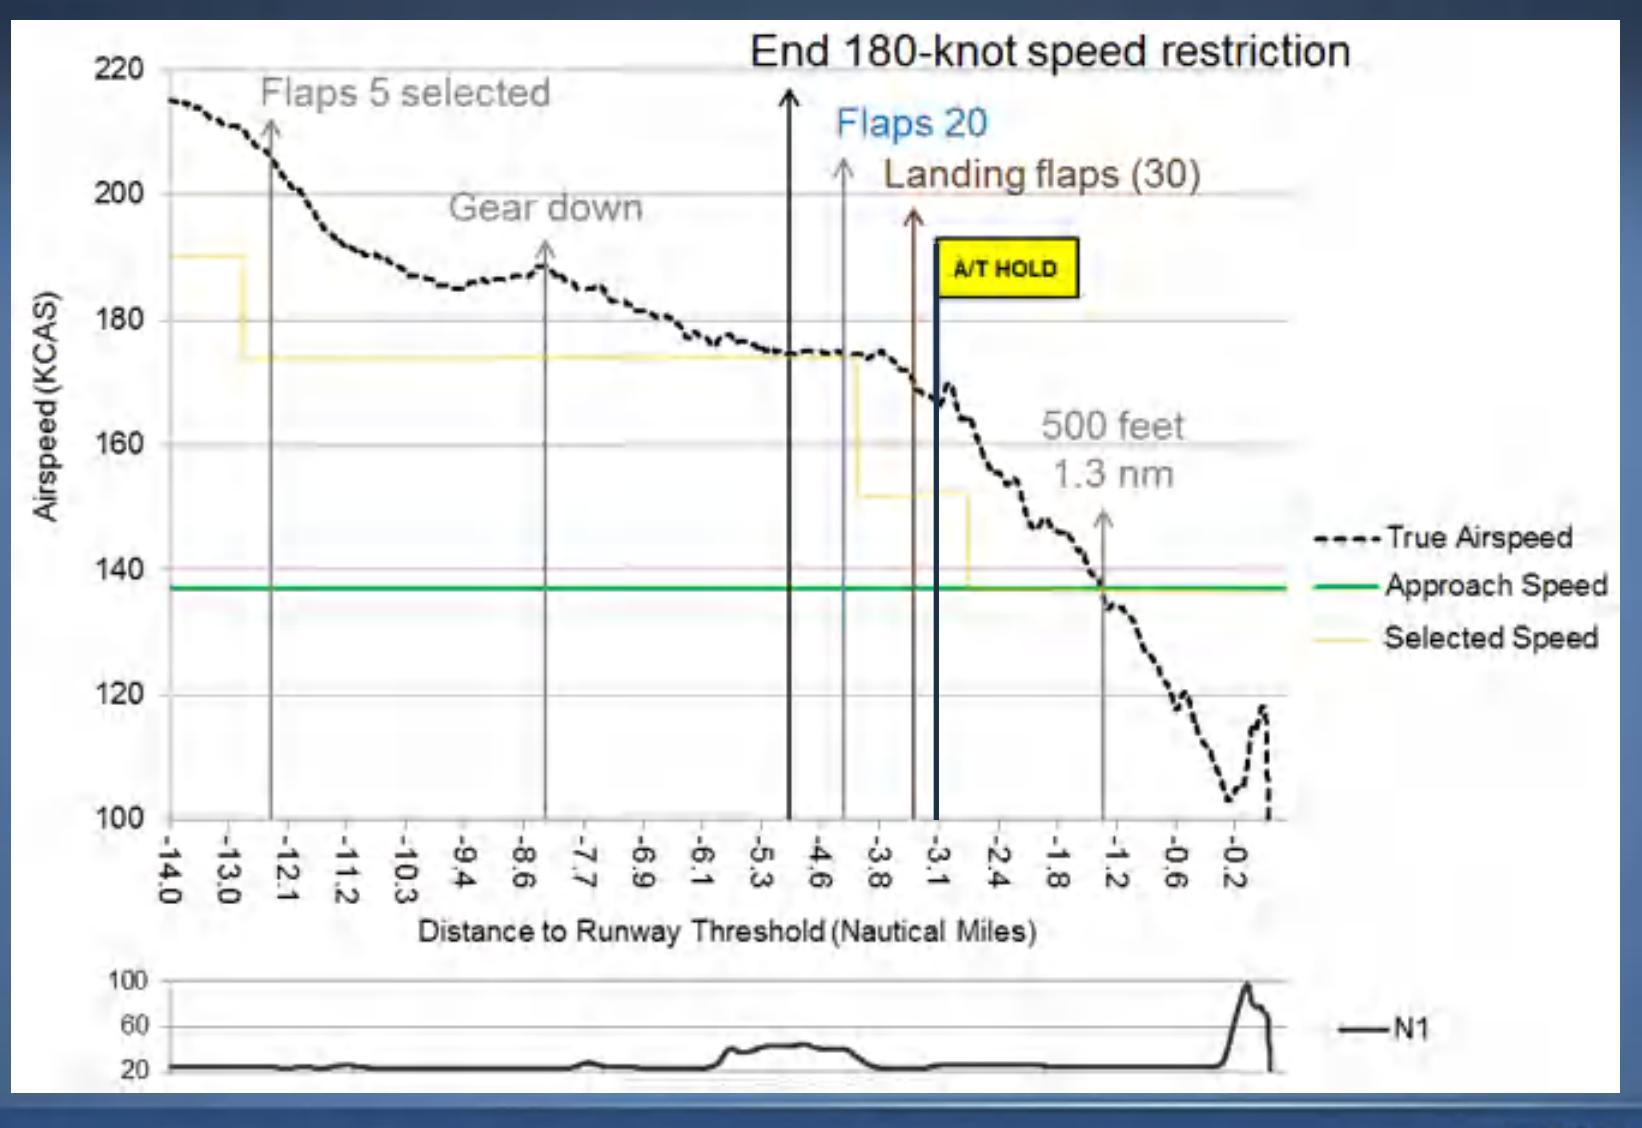
Deactivation of Automatic Airspeed Control

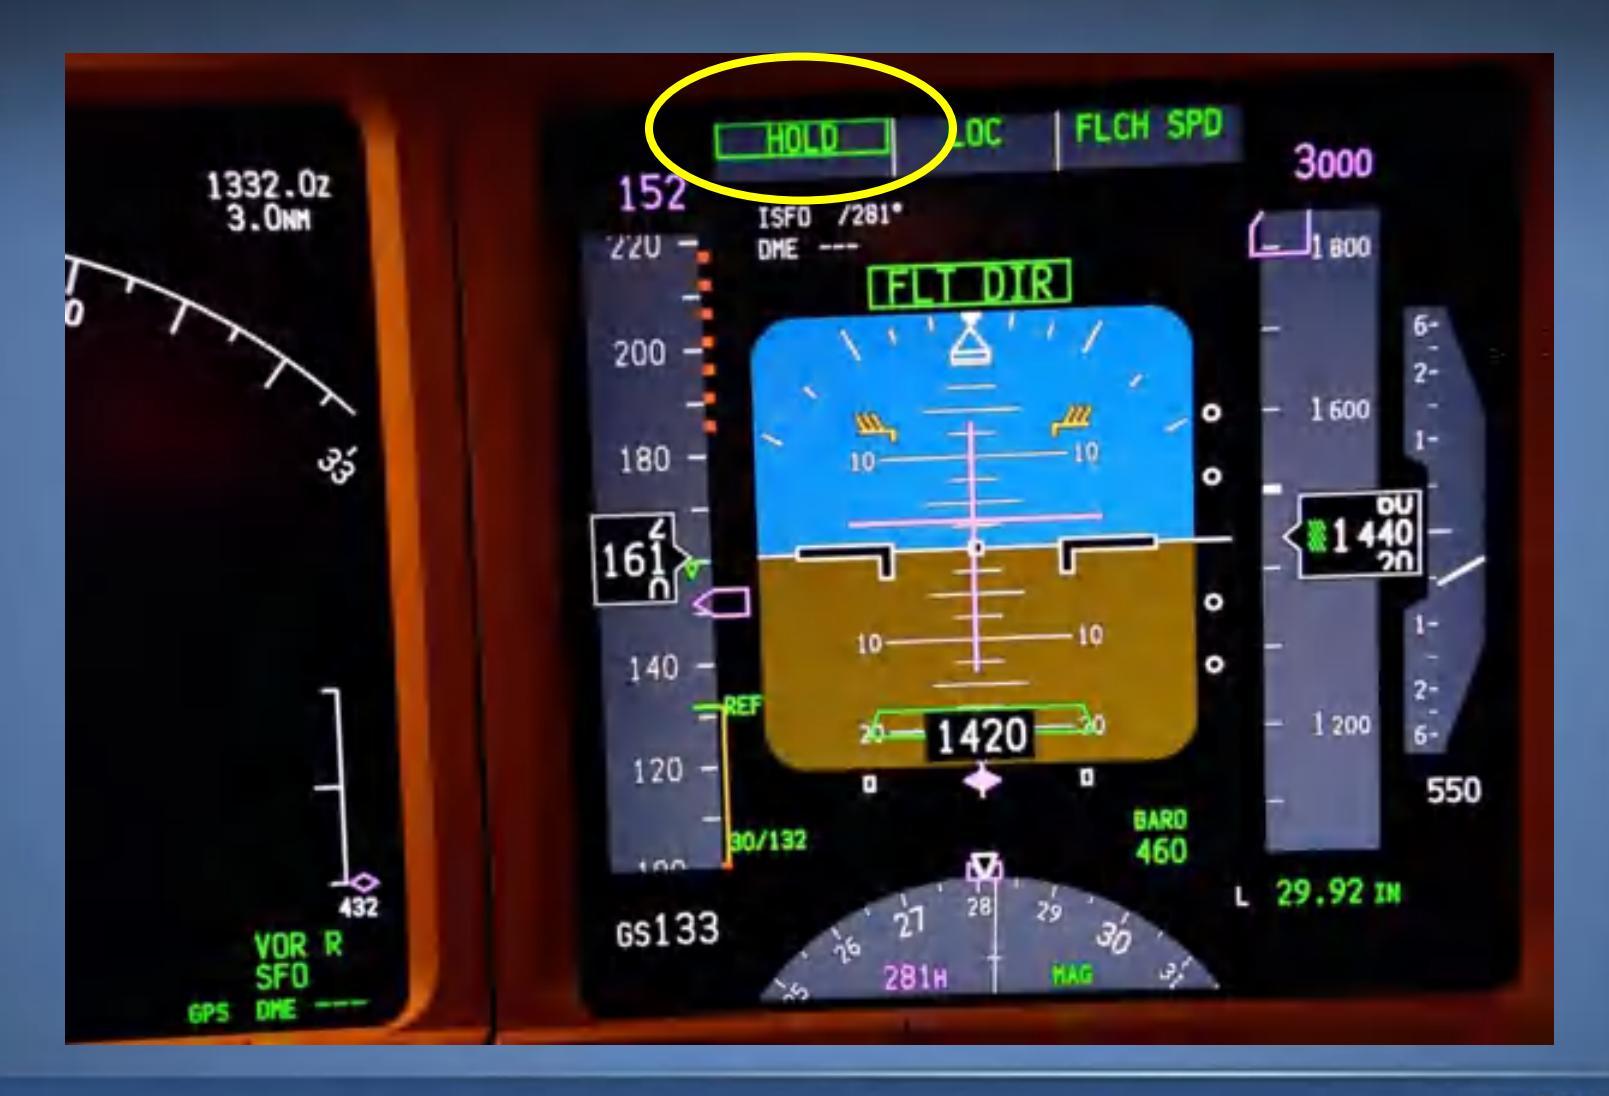
Flightcrew Non-Detection of the PF's Error

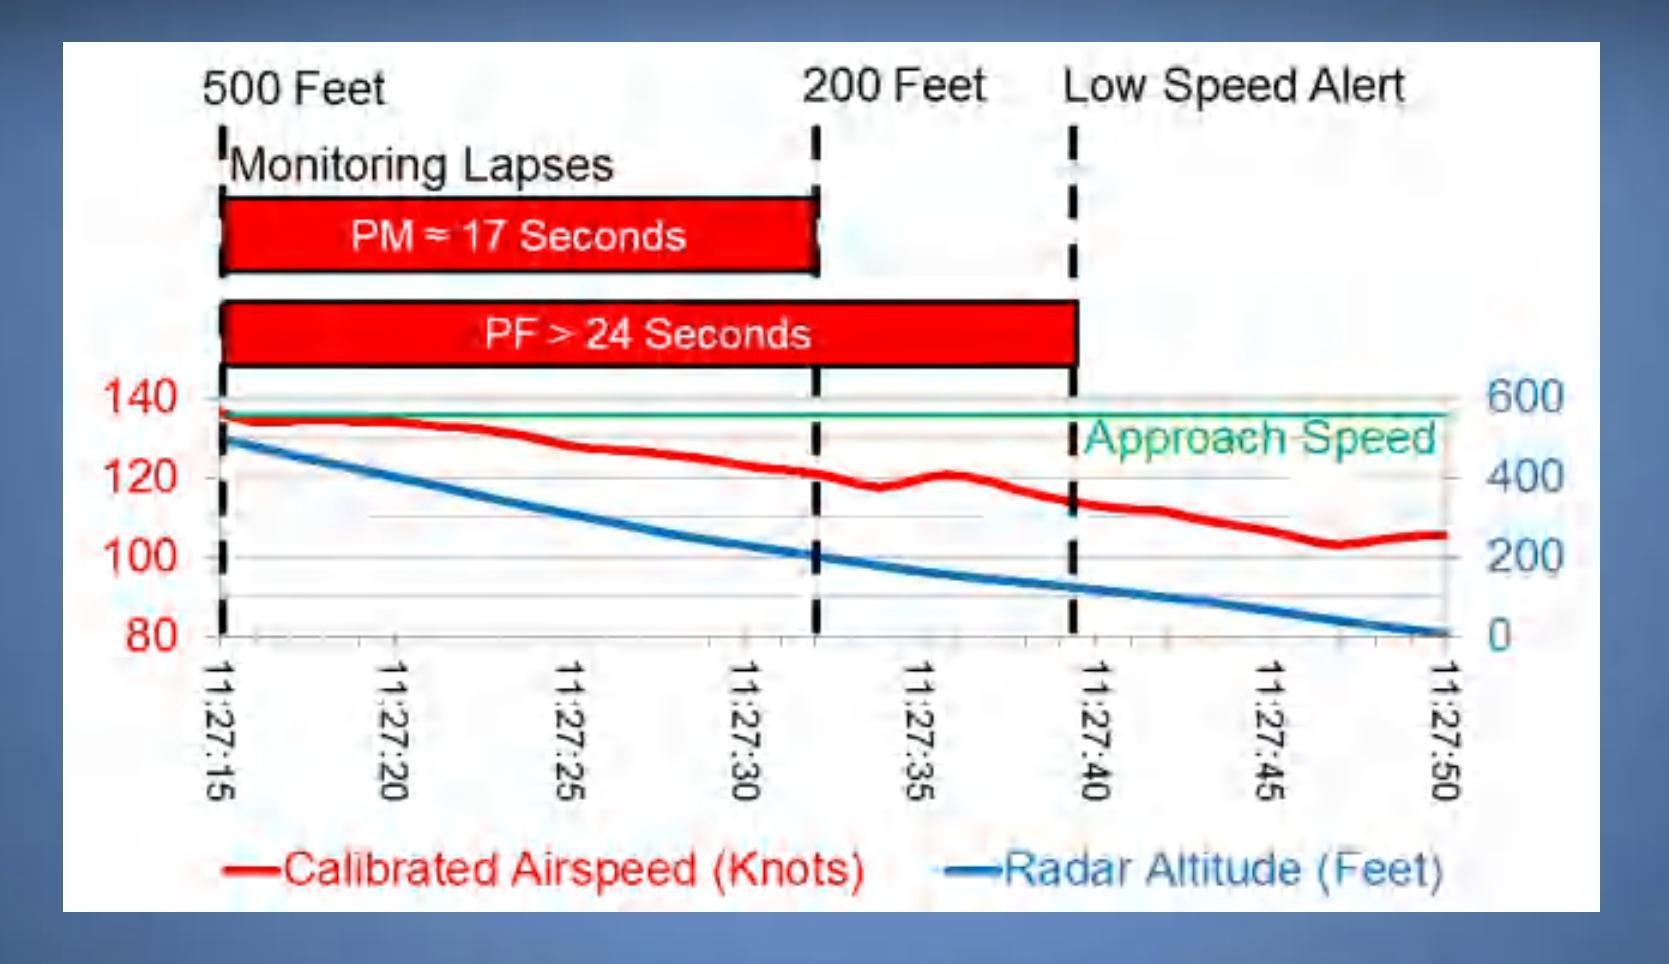
Inadequate Monitoring of Airspeed

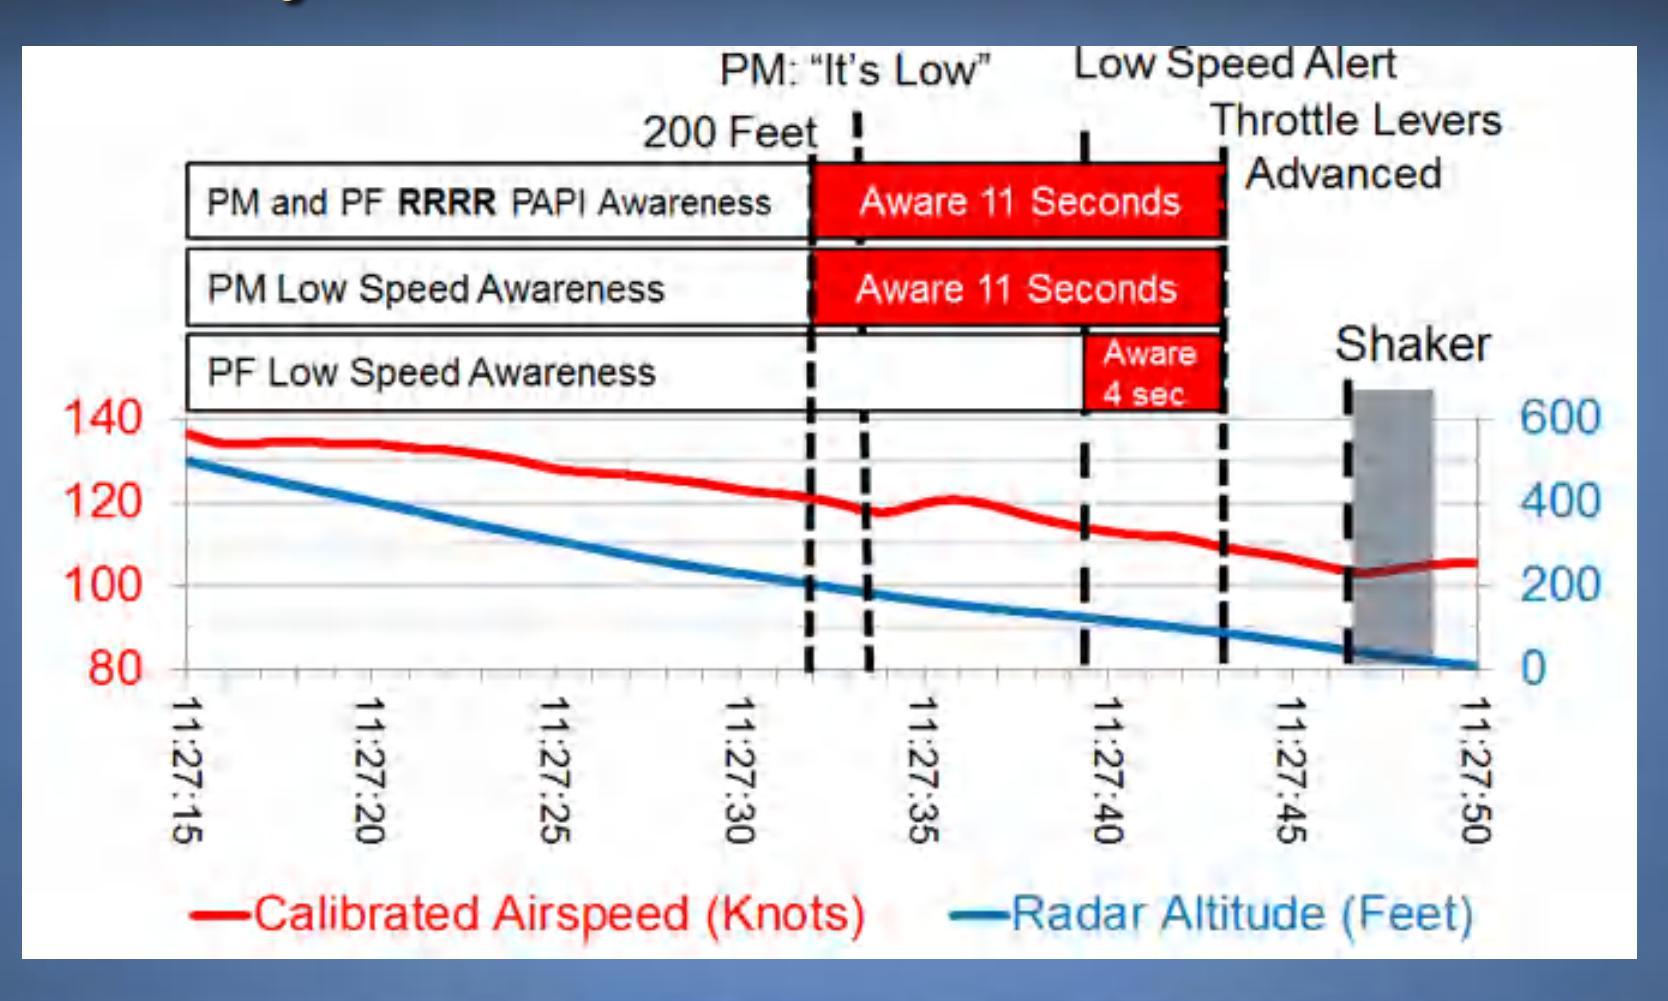
Delayed Go-Around

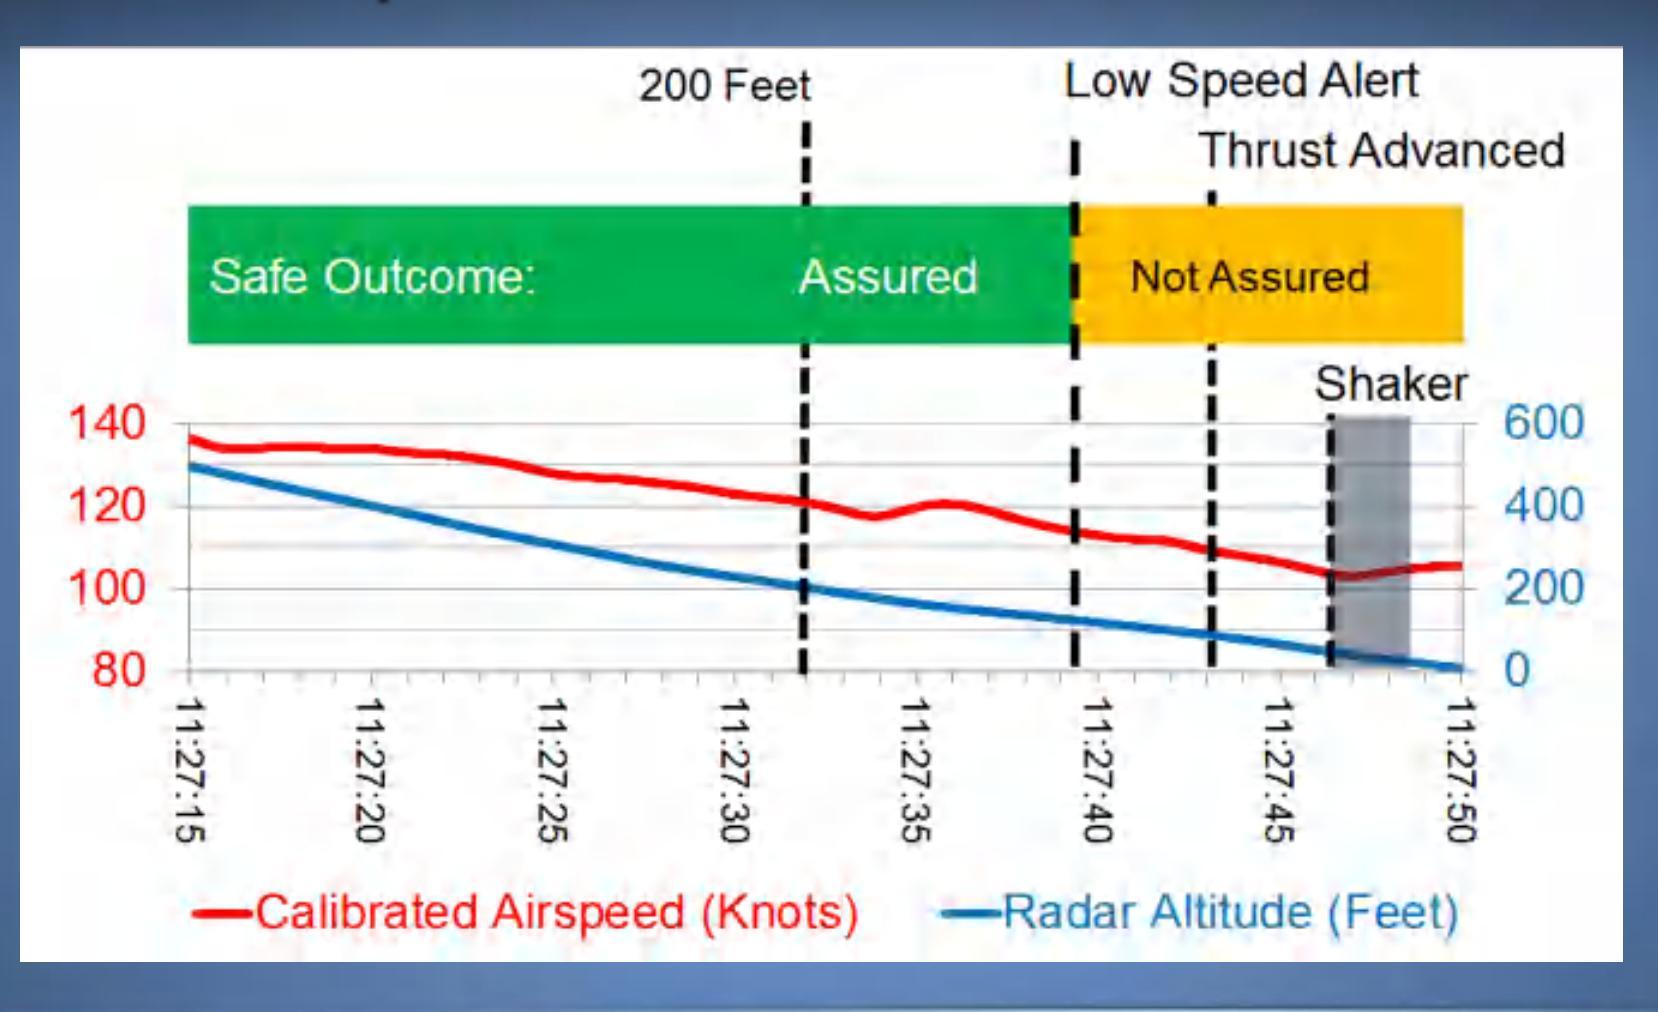
Low Speed Alert
