# Major Accident Investigation Review Boeing 747-4AF Freighter Accident Dubai, 2010

MENASASI, Abu Dhabi 27 May 2013

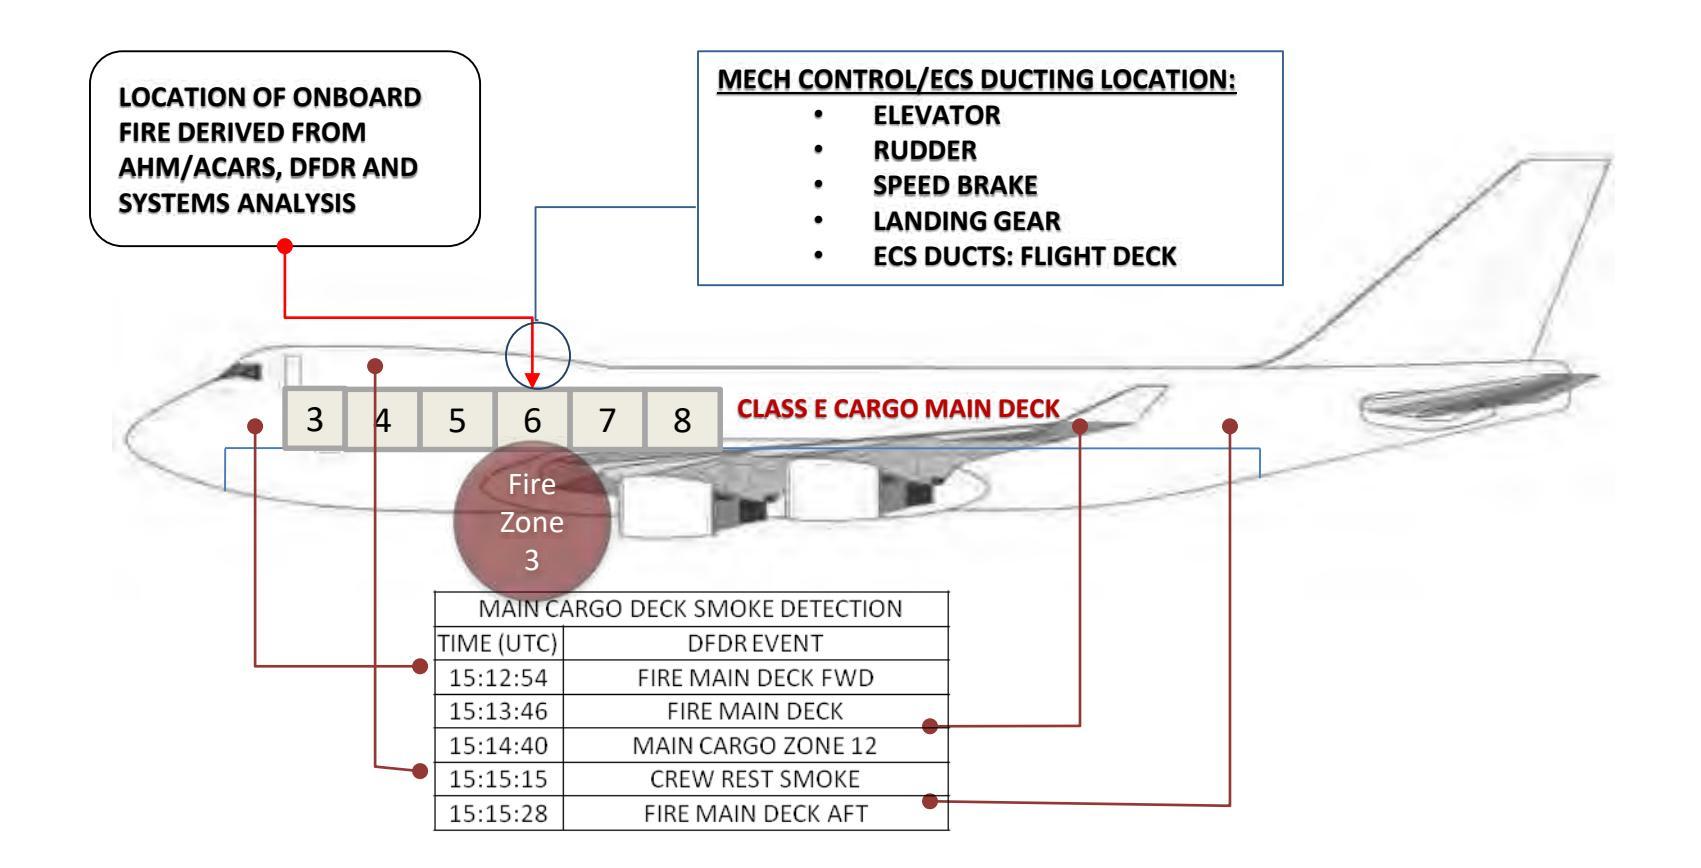
### Fire Origin/Point of Initiation

Based on the ACAR/AHM analysis the cargo fire originated in Zone 3 at 15:13 UTC

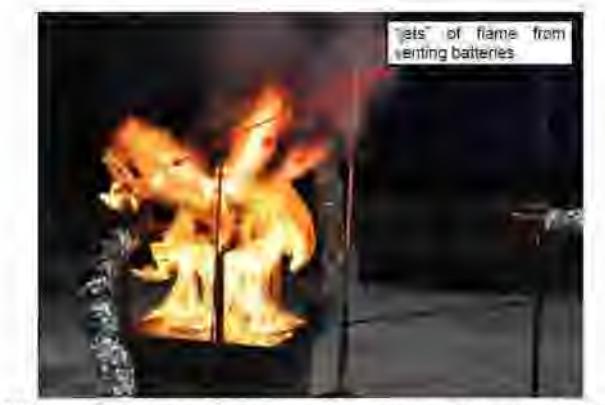
Figure 10: Box of lithium-ion batteries burning over propane burner exhibiting battery venting and electrolyte combustion Box of 100 lithium-ion batteries suspended over 30kW burner

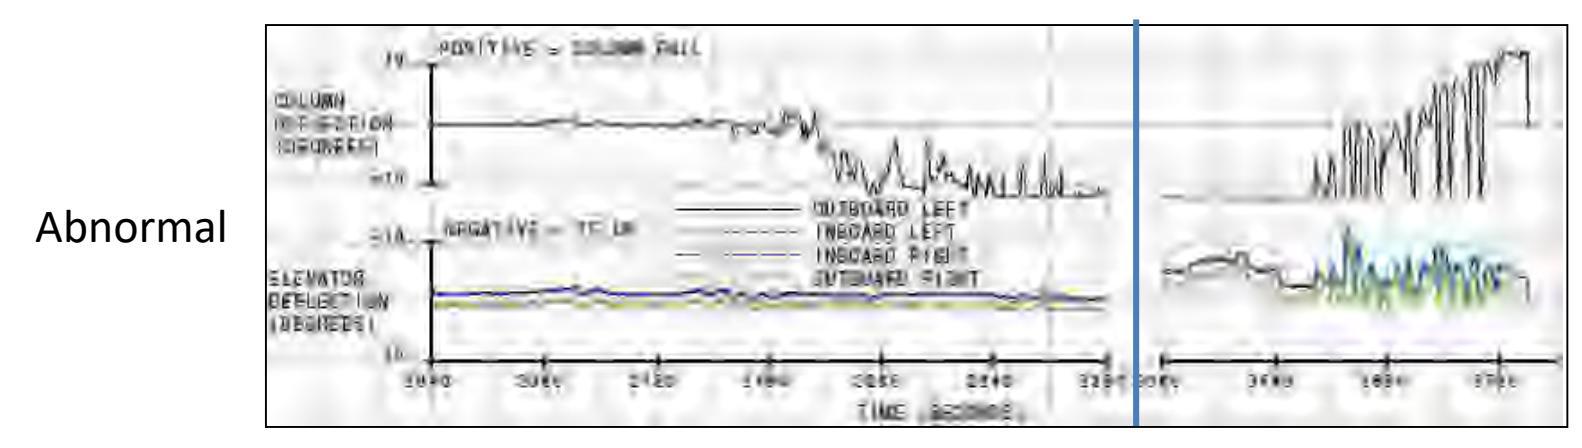
Following the initial fire warnings the column moved nose-down with no corresponding change in elevator deflection (left plot ). Near the end of the data, the FDR data shows nose-up column inputs

The elevator was deflecting with the column inputs but not with the relative magnitude seen in the figure above [Normal]. This indicates that there was some column cable tension but not enough to maintain normal column to elevator gearing.

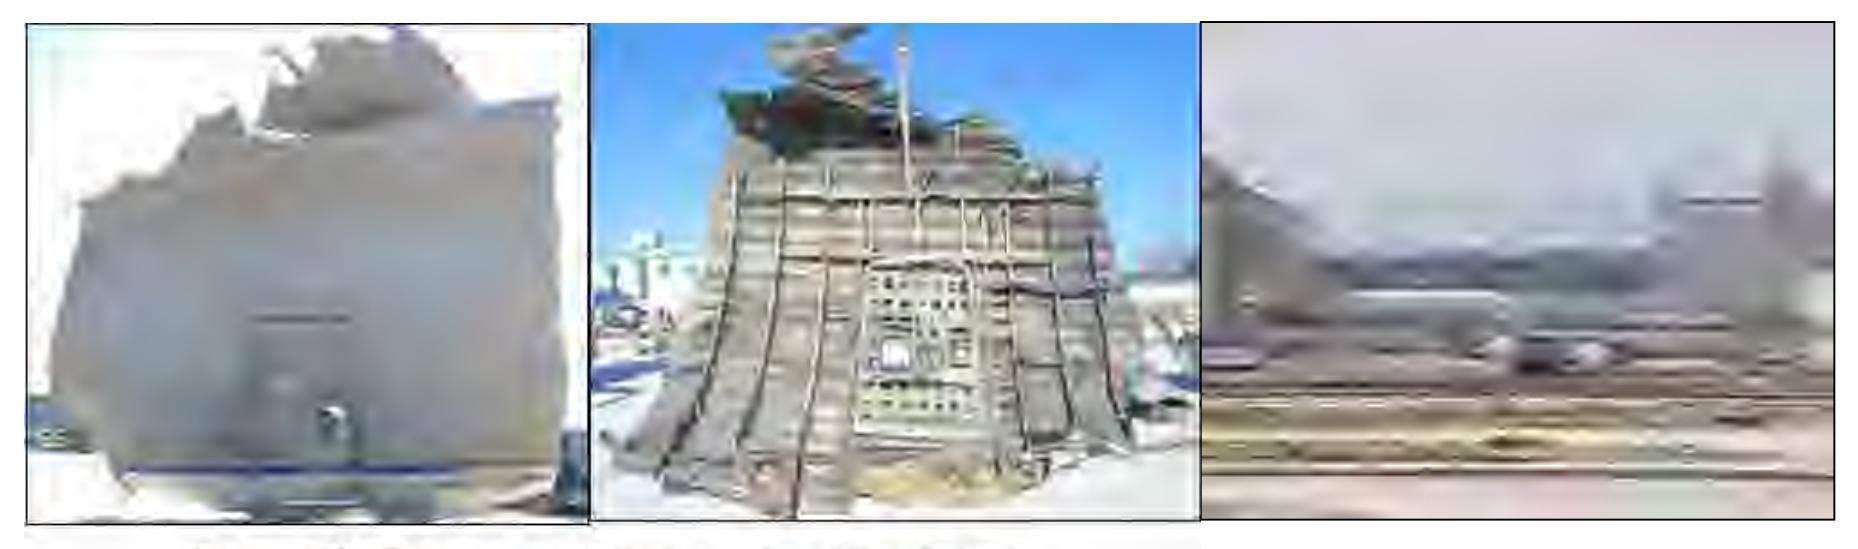
[Figure 23] Exterior and Interior Side of the L5 Door
