Annexes 11;13 &19 Bridging for Rapid Safety & Prevention Actions

Abdullah H. Bakr – Senior Air Traffic Services Investigator

■ Case Identifier (AIB-220823-1478)

- **Date:** On 22 August 2023.
- **Time:** 21:16 UTC (00:16 Local).
- **Aircraft:** Indigo airlines ,IGO066 (A321-Neo).
- **Route:** Jeddah (OEJN) to Cochin (VOCI).
- **Emergency :** Engine failure - Smoke in the cockpit/cabin during initial climb.

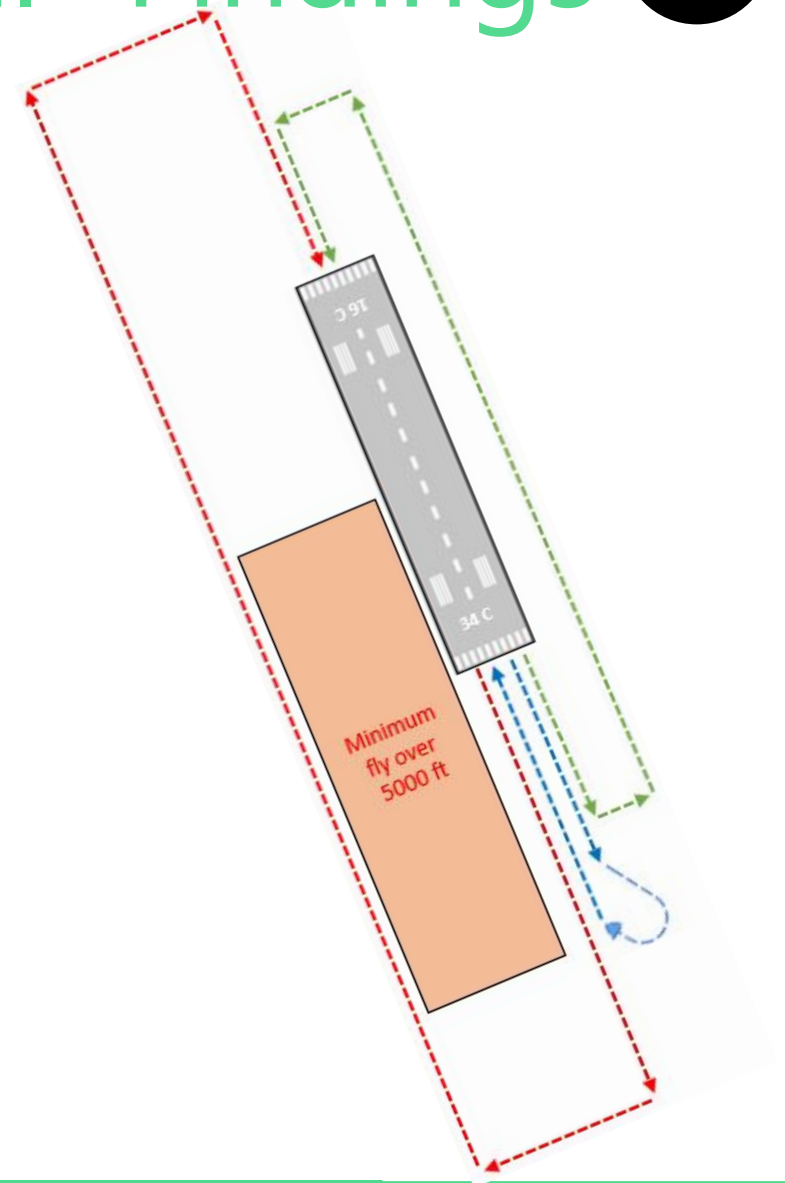
Air Traffic Services “Initial” Findings 1

1. ATC vectored an after-takeoff emergency flight for excessive distances

- Total flight time: 16 minutes
- Total Distance flown: 65 NM

Alternate shorter time and distance with optional vectoring:
(Left Circuit and course reversal for runway 34)

- Time Projected: 5 to 10 minutes
- Distance Projected: 15 to 40 NM

- Enabling flight crew in emergencies to choose the most suitable runway to land regardless of consequent operational impacts and prioritize it.
 - Utilization of the aerodrome traffic circuit for emergencies to minimize the flying distance if applicable.
 - Holding all other activities on a runway reserved for an emergency landing.
 - Adding a supervisor quick reference checklist for the required information to pass while notifying the FRS in cases of emergency.
