SEEKING INTERNATIONAL ASSISTANCE IN AIRCRAFT ACCIDENT INVESTIGATION FOR DEVELOPING NATIONS

9th & 10th Nov, 2014 – (MENA SASI)

**Wing Commander
Syed Naseem Ahmed
President SASI Pakistan**

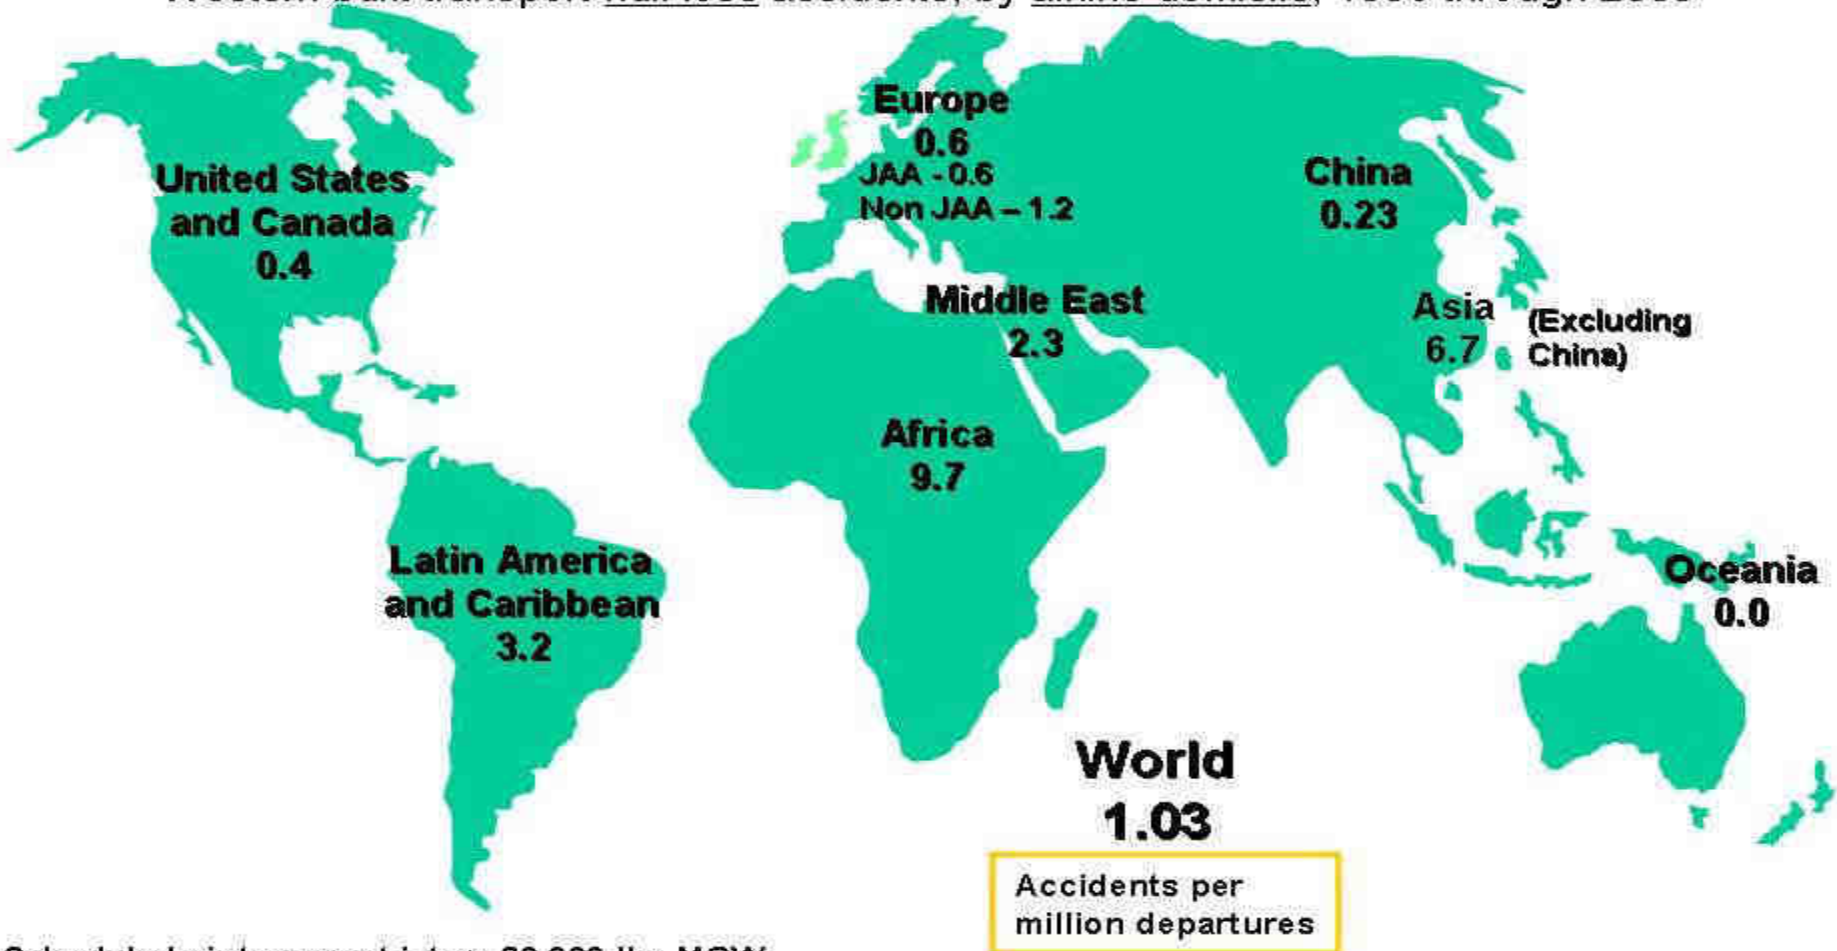
Aircraft Accident Rates 1996-2005

Western-built transport hull loss accidents, by airline domicile, 1996 through 2005*

Accidents per
million departures

* Scheduled air transport jets > 60,000 lbs MGW

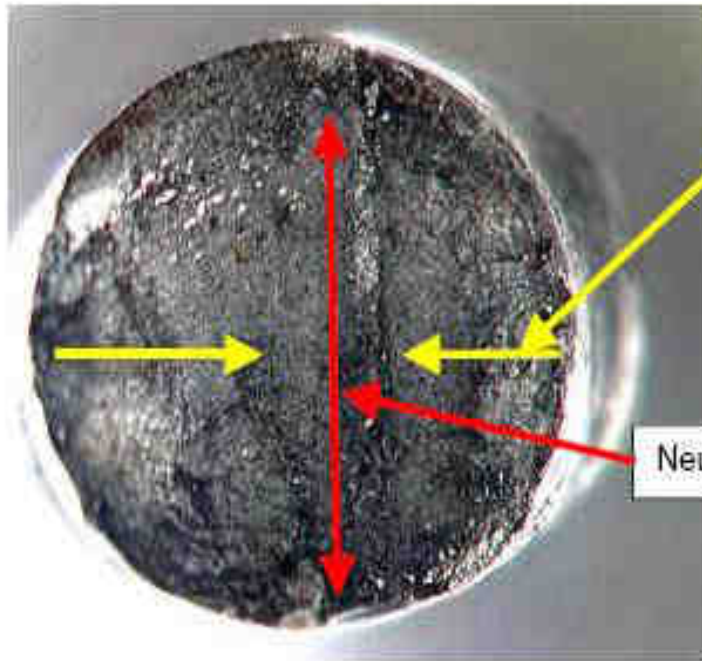
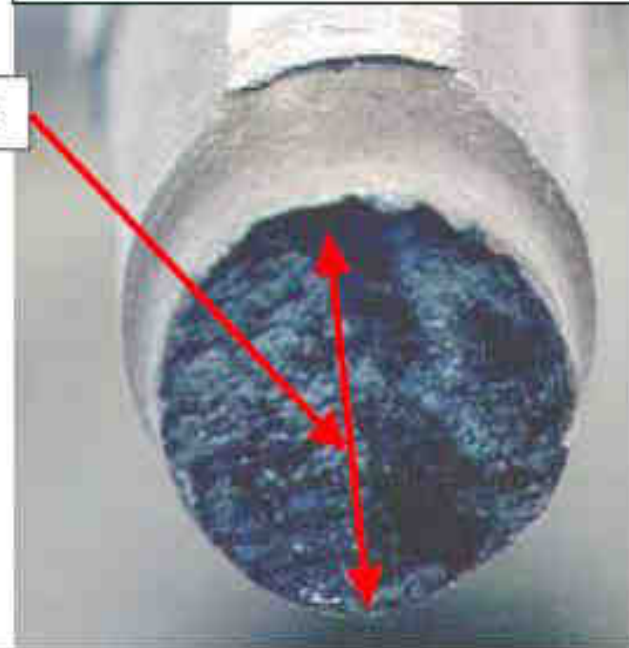
Figures 44 & 45. View showing the fracture face of the bolt that failed in the wasted section.

Reverse bending fatigue propagation direction indicated by yellow arrows

Fracture face of the bolt that failed in the wasted section showing the relationship between the neutral axis and the location 'lands' on the bolt shank diameter.

Neutral axis

Fracture face of the bolt that failed in the wasted section showing the neutral axis, the location of the reverse bending fatigue nucleation sites and the direction of fatigue propagation. The neutral axis of this failure is parallel to the 'D' flat of the bolt head.

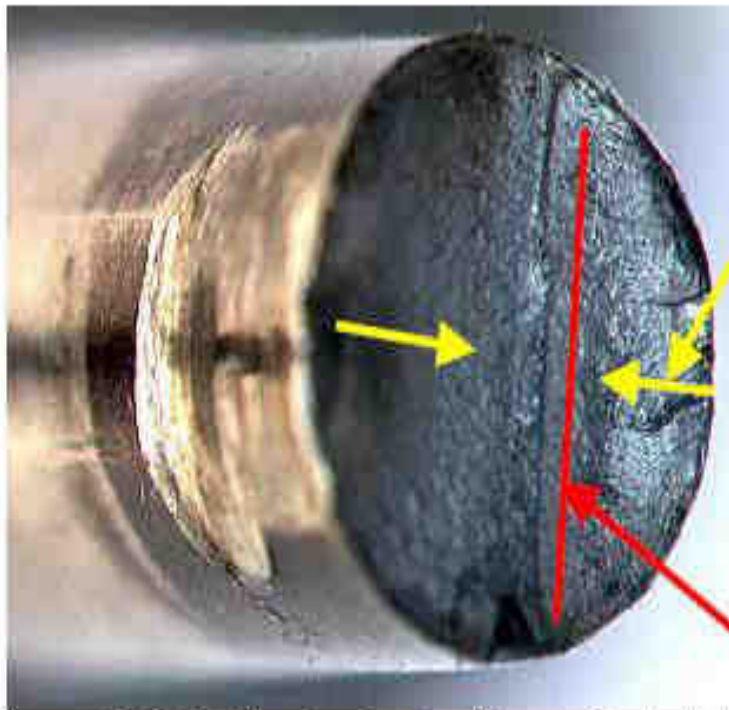
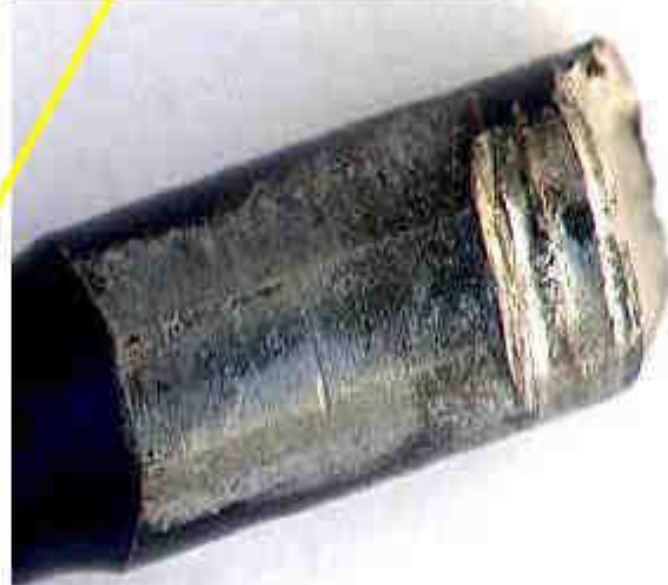
Figures 46 & 47. Showing fracture faces of the bolt that failed in fatigue in the location shank.

Fracture face of the bolt that failed in the shank section showing the neutral axis, the location of the reverse bending fatigue nucleation sites and the direction of fatigue propagation. The neutral axis of this failure is at 90° to the 'D' flat of the bolt head.

Reverse bending fatigue propagation direction indicated by yellow arrows

Neutral axis

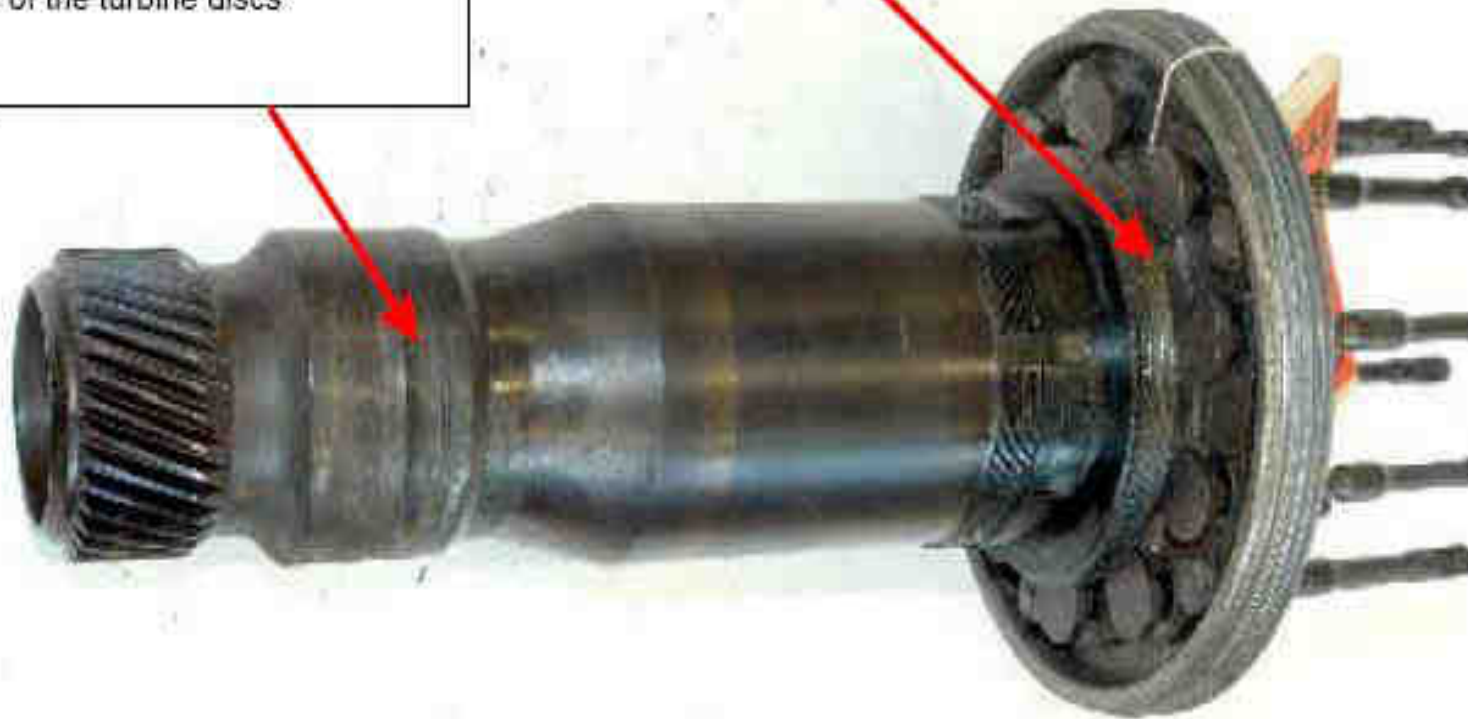
Figure 20. LPT shaft. View showing position and arc of heavy rub to the plain bearing journal.

Rub to plain bearing journal over an arc of 180° in same plane as the rub to the interstage labyrinth fins of the turbine discs

Oil seal to rear of bearing inner track.

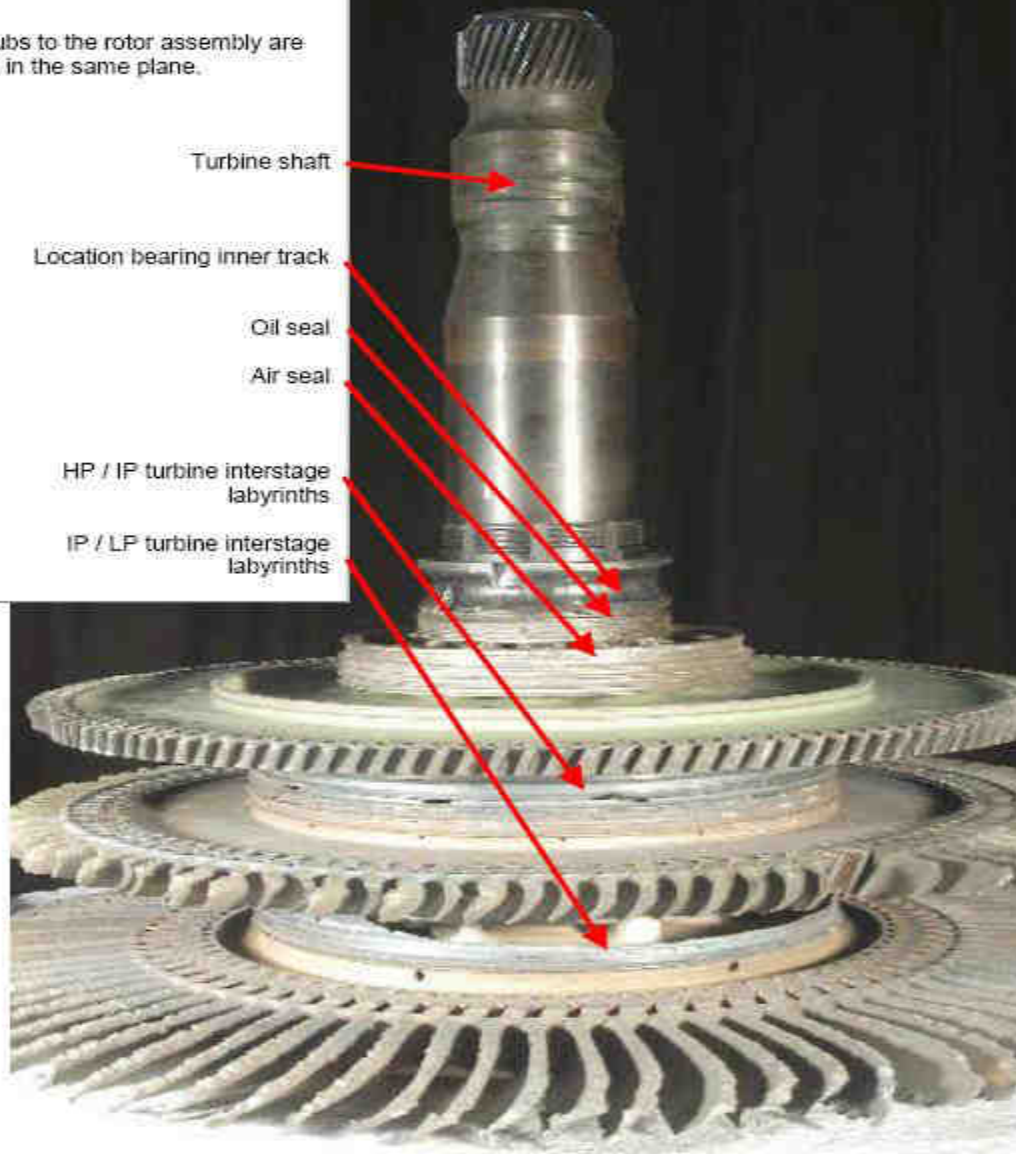
Similar view to figure 22, with the rotor turned through 90°.

Rubs to the rotor assembly are all in the same plane.

Turbine shaft

Location bearing inner track

Oil seal

Air seal

HP / IP turbine interstage
labyrinths

IP / LP turbine interstage
labyrinths

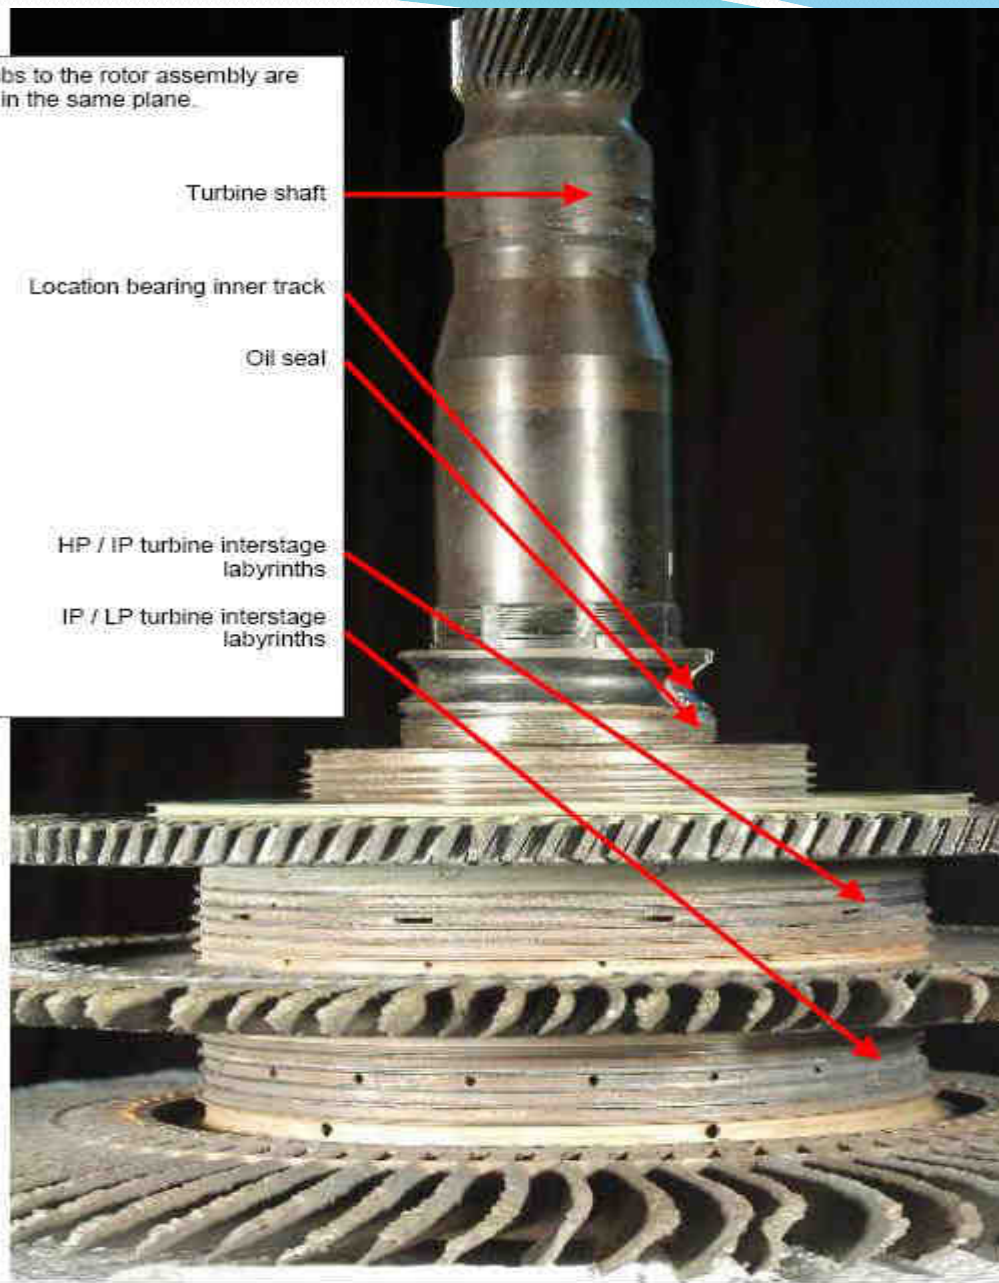
Rubs to the rotor assembly are
all in the same plane.

Turbine shaft

Location bearing inner track

Oil seal

HP / IP turbine interstage
labyrinths

IP / LP turbine interstage
labyrinths
