National Transportation Safety Board

A Human Factors Analysis of the Asiana Flight 214 Accident

MENASASI Seminar, Dubai, United Arab Emirates, 5 November, 2015

Descent Below Visual Glidepath and Impact With Seawall Asiana Airlines Flight 214 Boeing 777-200ER, HL7742 San Francisco, California July 6, 2013

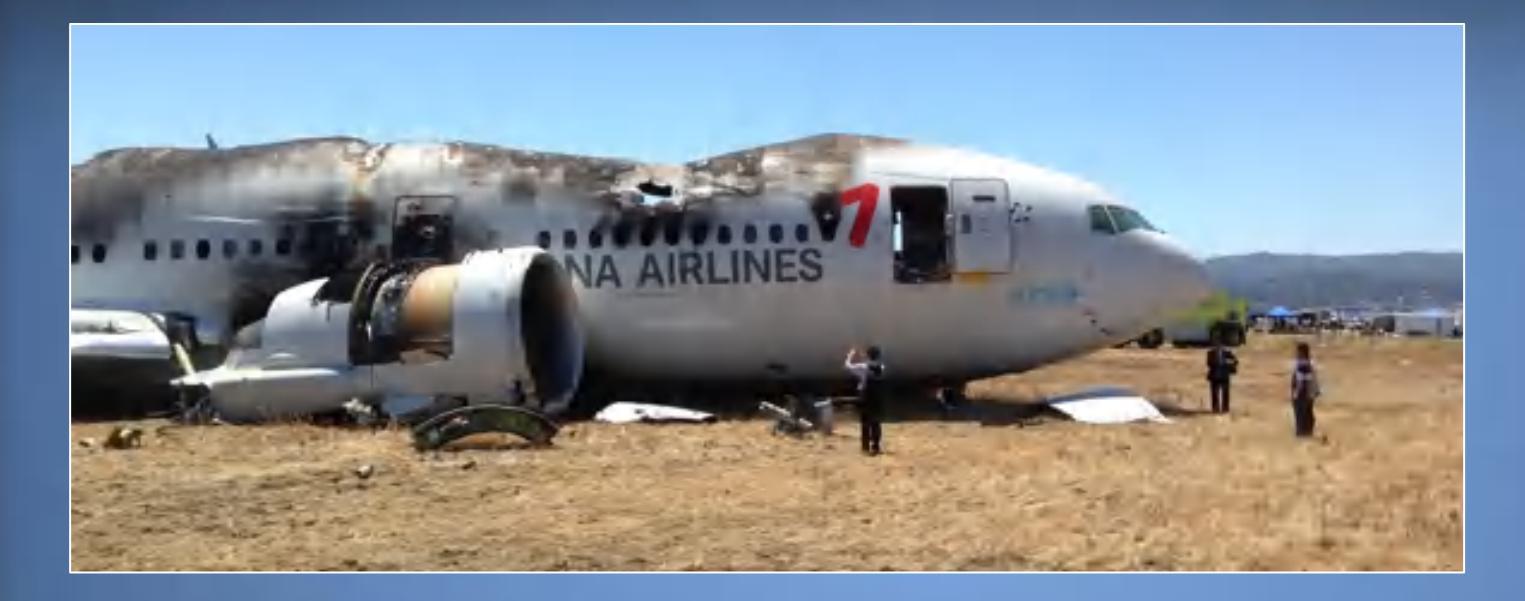
Probable Cause

Flightcrew's mismanagement of airplane's descent PF's unintended deactivation of automatic airspeed control Flightcrew's inadequate monitoring of airspeed

Flightcrew's delayed initiation of a go-around

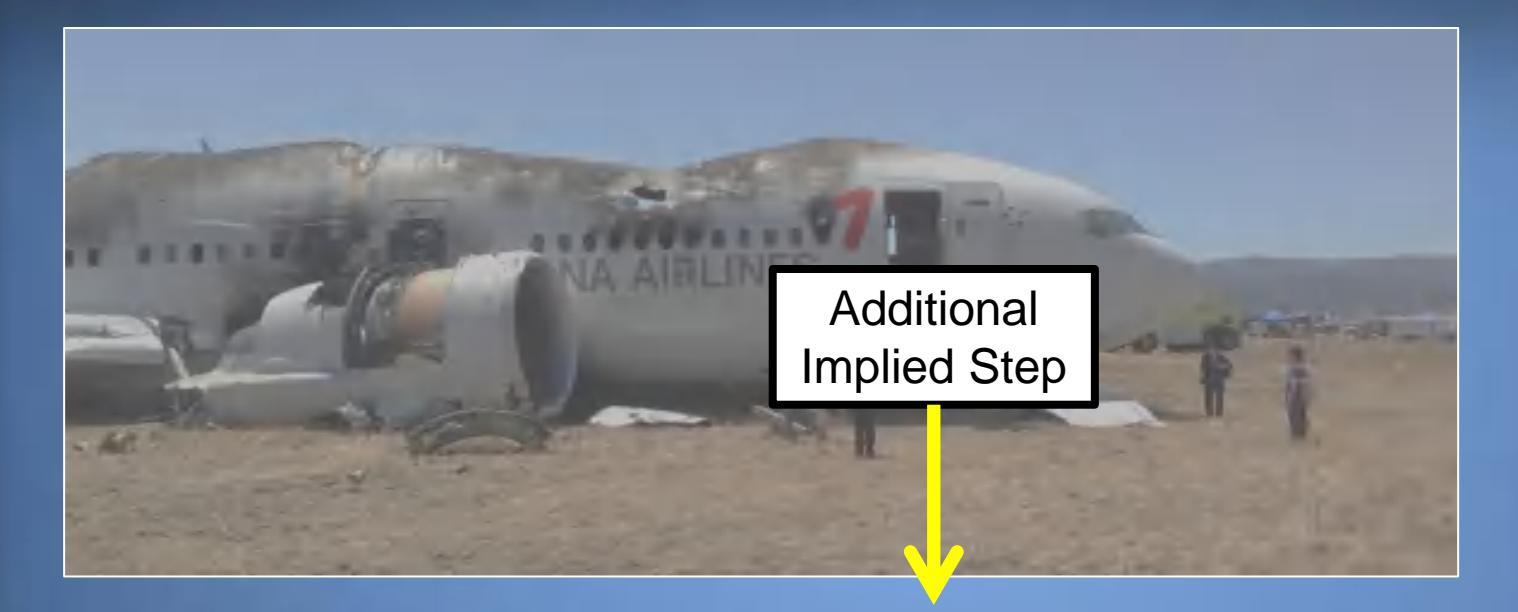
Probable Cause

Flightcrew's mismanagement of airplane's descent PF's unintended deactivation of automatic airspeed control

Flightcrew's nondetection of the PF's error Flightcrew's inadequate monitoring of airspeed

Flightcrew's delayed initiation of a go-around
