## A Human Factors Analysis of the Asiana Flight 214 Accident

*William Bramble, Ph.D.  
Senior Human  
Performance Investigator*

# Accident Information

- July 6, 2013
- Boeing 777-200ER
- Scheduled flight
- Seoul → San Francisco
- Training flight
- Visual meteorological conditions
- Light winds

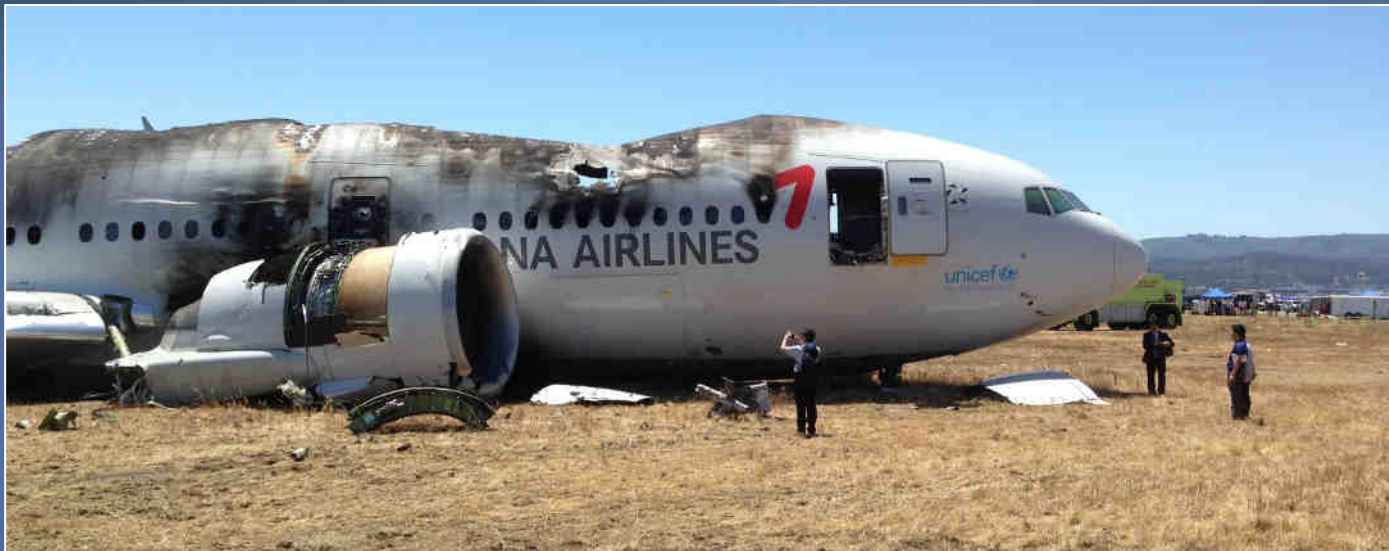
# Probable Cause

Flightcrew's  
mismanagement  
of airplane's  
descent

PF's unintended  
deactivation of  
automatic  
airspeed control

Flightcrew's  
inadequate  
monitoring of  
airspeed

Flightcrew's  
delayed initiation  
of a go-around
