# Major Accident Investigation Review Boeing 747-4AF Freighter Accident Dubai, 2010

MENASASI, Abu Dhabi 27 May 2013

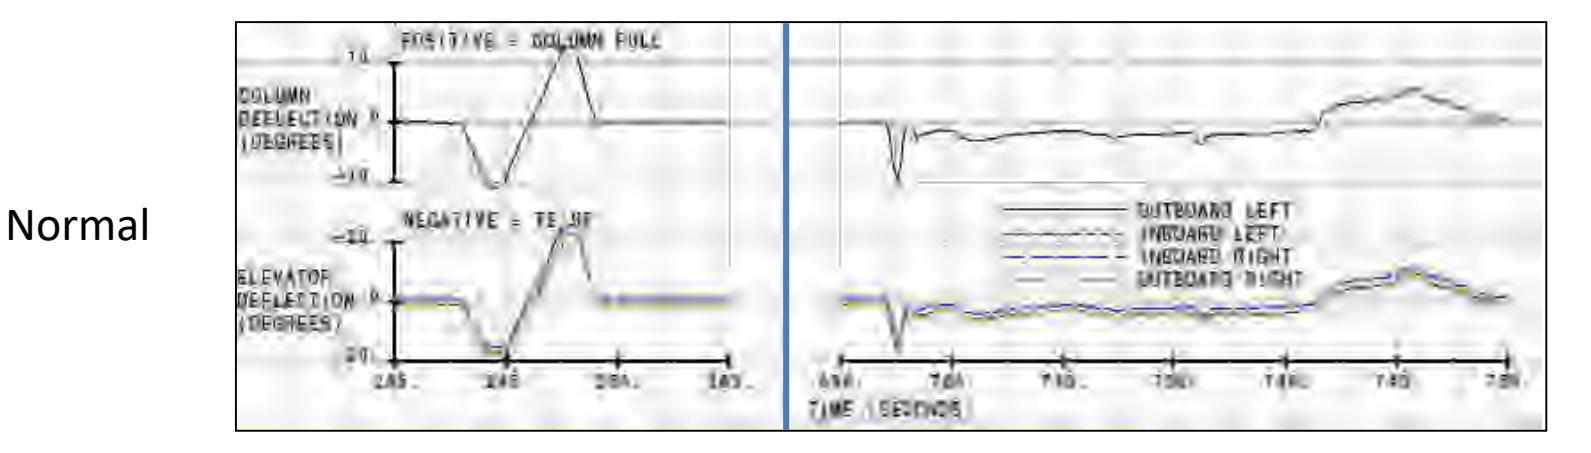
### **Control Column/Elevator Desynchronization**

Column sweep and take-off rotation display the normal relationship between column and elevator. If the tension is below the allowable tolerance, the column and elevator will no longer be consistent.

Following the initial fire warnings the column moved nose-down with no corresponding change in elevator deflection (left plot ). Near the end of the data, the FDR data shows nose-up column inputs

The elevator was deflecting with the column inputs but not with the relative magnitude seen in the figure above [Normal]. This indicates that there was some column cable tension but not enough to maintain normal column to elevator gearing.

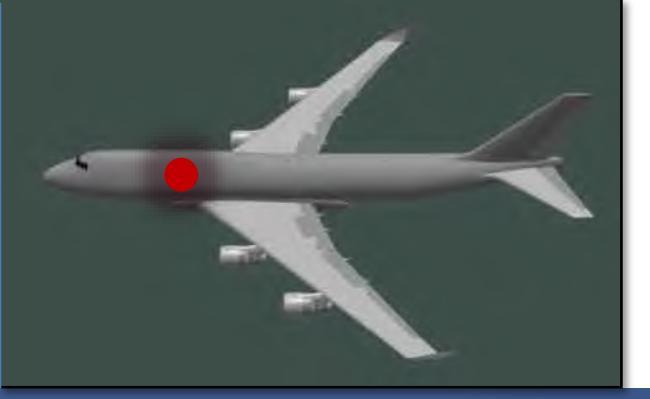
15:17[04]: Smoke in the cockpit-Reduced Visibility Due to Smoke

15:18[05]: Flight Management Computer [FMC] Inputs

> 15:20 [07]: Crew Oxygen System Anomalies-Captain and First Officer

15:22[09] : Pilot Incapacitation - Captain 15:22[09] : Pilot Incapacitation - Captain 15:22 to 15:41[09-19]: Radio Communication - Relay Aircraft

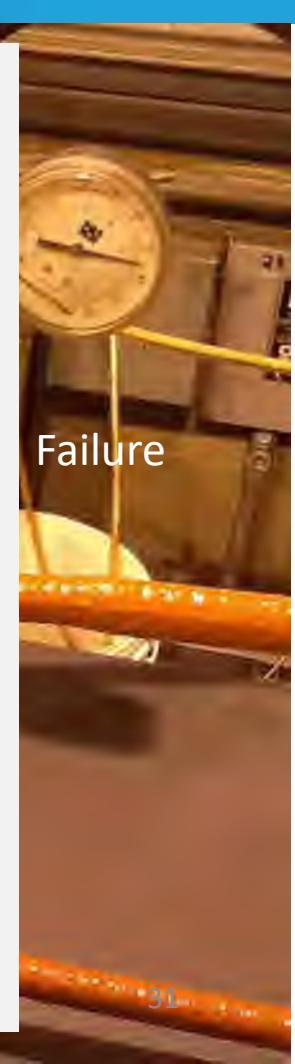
Failure Summary:

- SBD on at: 12:14:50 [Local]
- ii Initially the mask operated as expected.
- iii As the IR camera indicated the progression of the heated air and the heating of the tubing, a fissure in the 60B50059 hose was detected at the T3 junction of the 3/8" CRES/60B50059 oxygen hose connector coupling joint, followed by an detectable increase in the size of the fissure downstream from the CRES/60B50059 hose connector as the heated air flow increased.
  iv Flex hose 60B50059 failed at 12:21:20 [Local]
- v The manometer reading went above the 4 inches of water limit cut off and the test was discontinued.

- Elapsed time between starting and the hose failure was: 7min 30 sec
- Failure of the 60B50059 hose fitting between the CRES connector and the Mask Stowage Box.
- White smoke was observed to be emanating the mask. The mask was removed and secured for further detailed examination with the mask manufacturer.

Thermocouple temperature values at the termination of Test 1

Mask	T1	T2	Т3	T4
Delivery	67.41F	1042.7F	720.4F	72.56F
Temps	18C	561.5C	382.2C	21.81C

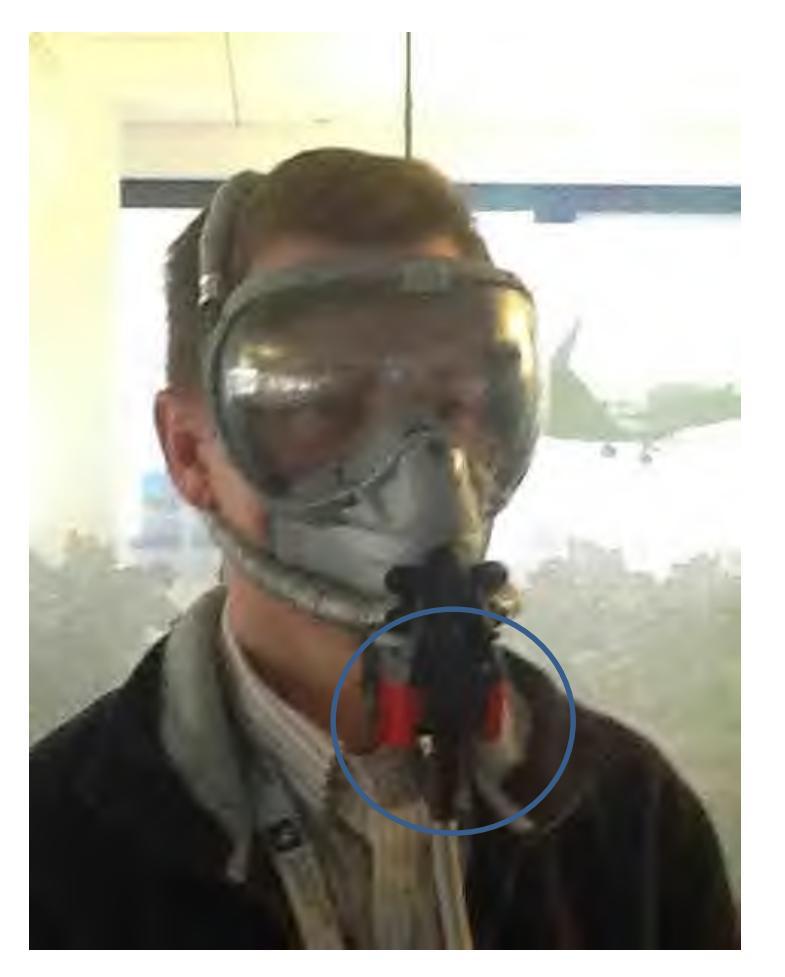
### New Design Full Face Oxygen Mask

Redesigned oxygen selector:

Simplified rotating selector for selecting <u>Normal, 100% or Emergency.</u>
